Aries

CSP microstrip socket
Cycling Test
DC Measurement Results

Gert Hohenwarter

2/7/2005

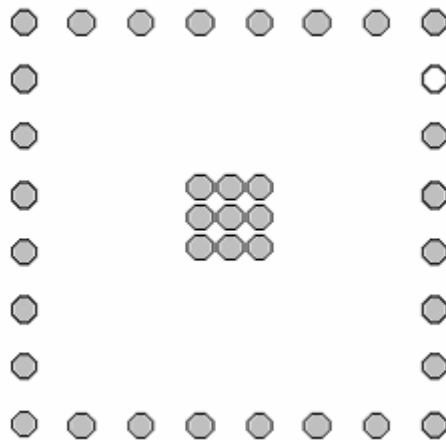
Figure 1 CSP socket test arrangement

To avoid any cross-effects from dc testing on RF characterizations, a different contact is used for this program. As shown in Fig. 1, the contact under test is on the side of the socket, typically the second from the top. The same contact will be used for all dc measurements, shown here in white.

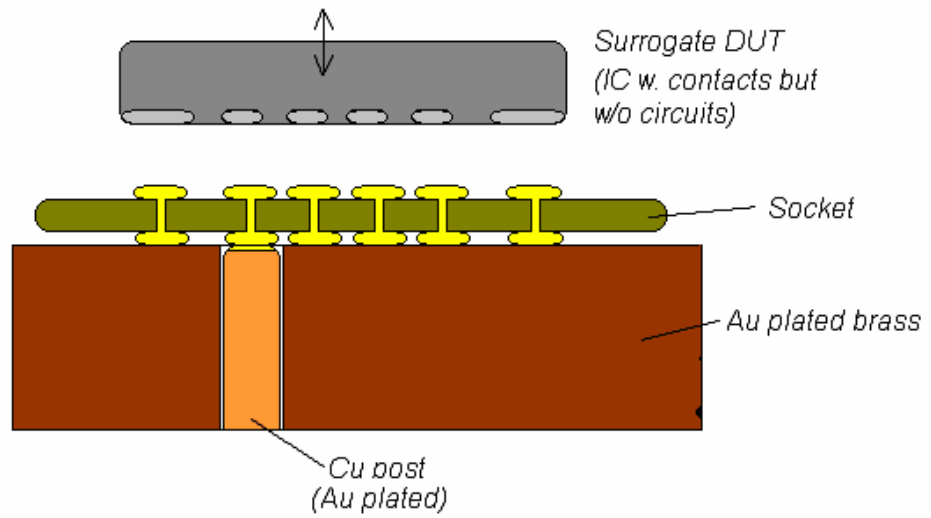
Figure 3 Cycling setup for socket testing

Sketches of the setups used during load cycling and testing are shown in the figures below:

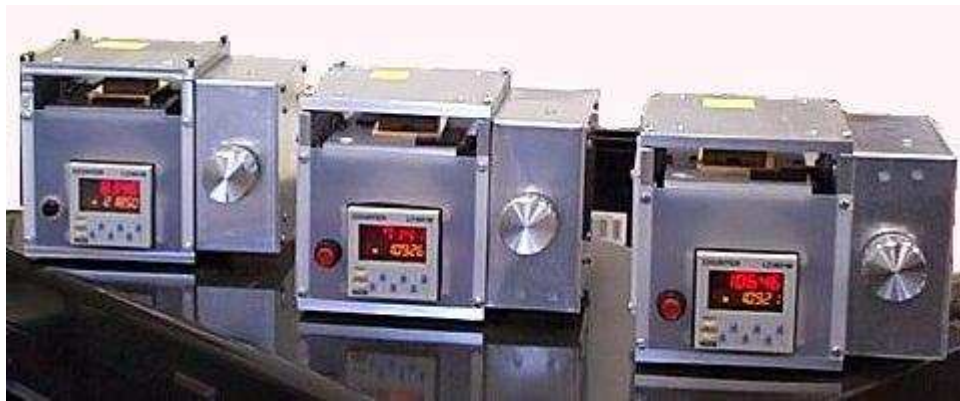
Figure 8 Parallel plate cyclers

Two different types of cycling apparatus were used. Depending on the socket type either a mechanical cyler with parallel plates moving by a small amount or a solenoid based cyler were used. Displacement was typically established such that the surrogate test devices bottom out in the socket.

For the parallel plate setup force limiting was accomplished by inserting a thin hard rubber sheet between the DUT and the moving plates. Parameters were selected such that under maximum deflection and normal cycling conditions the surrogate device

touches the bottom of the socket. Where necessary, pressure sensitive paper was used to verify this condition. Maximum speed of this setup was 3 cycles per second.

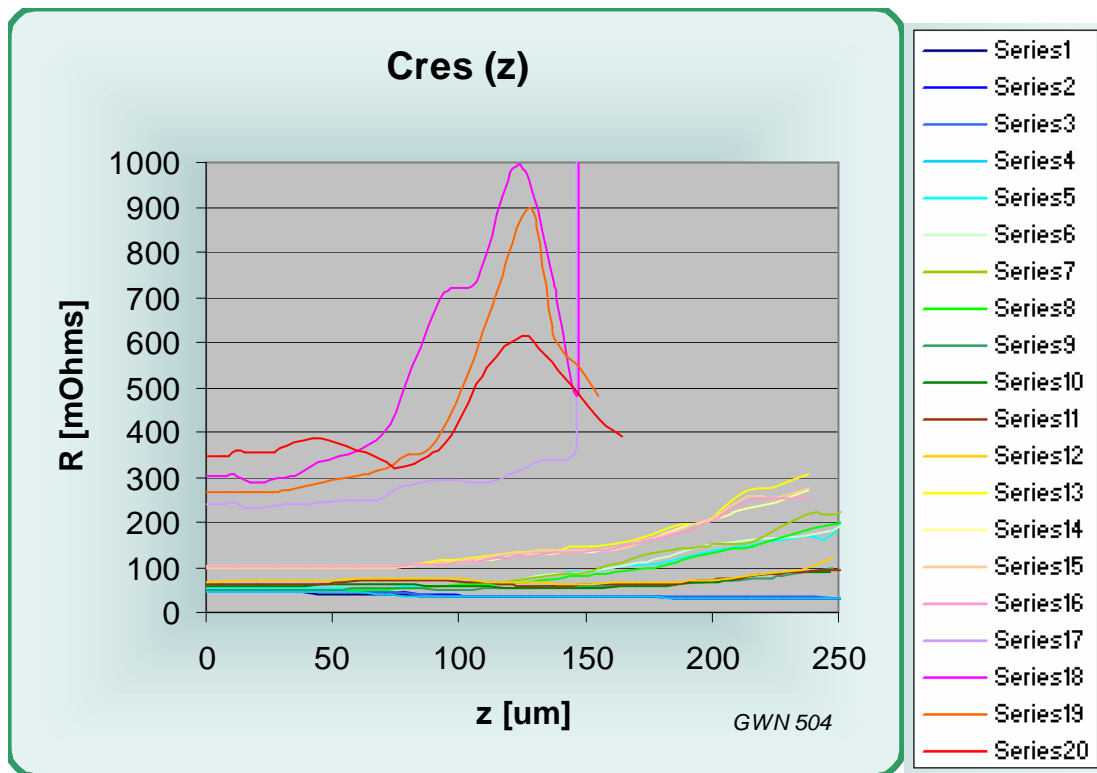
Figure 9 Contact resistance as a function of displacement

For this graph, the value $z=0$ represents the maximum compression in operation, i.e. with the DUT fully inserted. The results are corrected with the functional dependence of resistance as a function of displacement as obtained via regression during the cycle

0 test. As cycle numbers increase (=> series#), so does the overall resistance. It should be kept in mind here, that the resistance indicated includes contact resistance to the probe (=loadboard), the DUT, and the contact itself. For complex contact assemblies, this may be a significant contribution to the overall value.

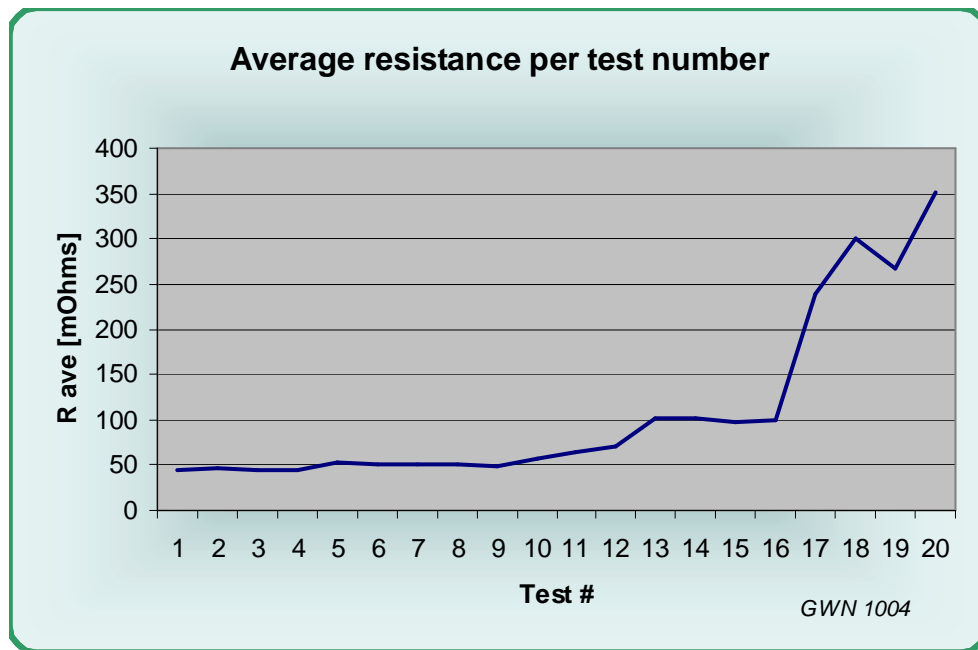
Figure 10 Contact resistance as a function of test number

As a measure of change throughout the cycles, the average resistance for the last 5 data points before the plunger reaches full insertion are plotted as a function of cycle number:

There is some resistance increase with increasing cycle numbers. It should be kept in mind, that the socket under test undergoes a number of matings/dematings with the test plates and probes. This may affect the backside contact of the socket and therefore the results shown.

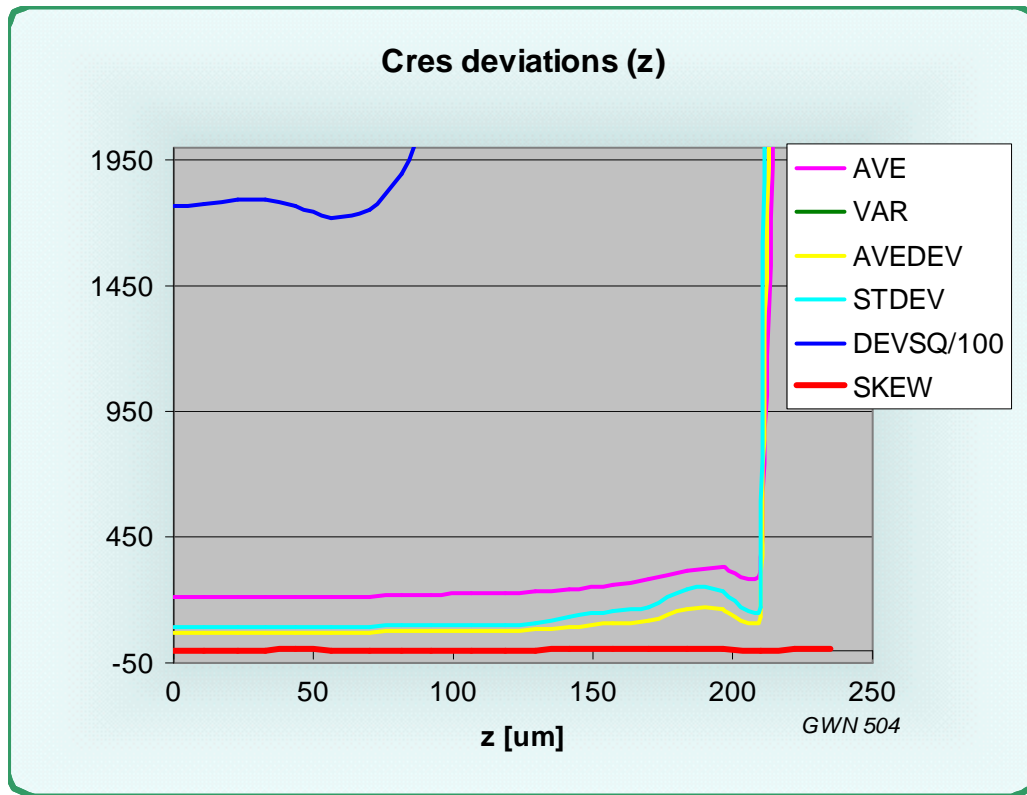
Figure 11 Statistics as a function of displacement

Also offered as a measure of contact performance are the deviations of the resistance as a function of displacement (plunger position, see graph below). Not

surprisingly, average and variability increase when less displacement (force) is applied by the plunger.

The dataset used for the statistical function is the recorded resistance at a particular displacement for the cycles from 1-20. Data are then displayed for each displacement from minimum to maximum. The following definitions are used (from MS Excel):

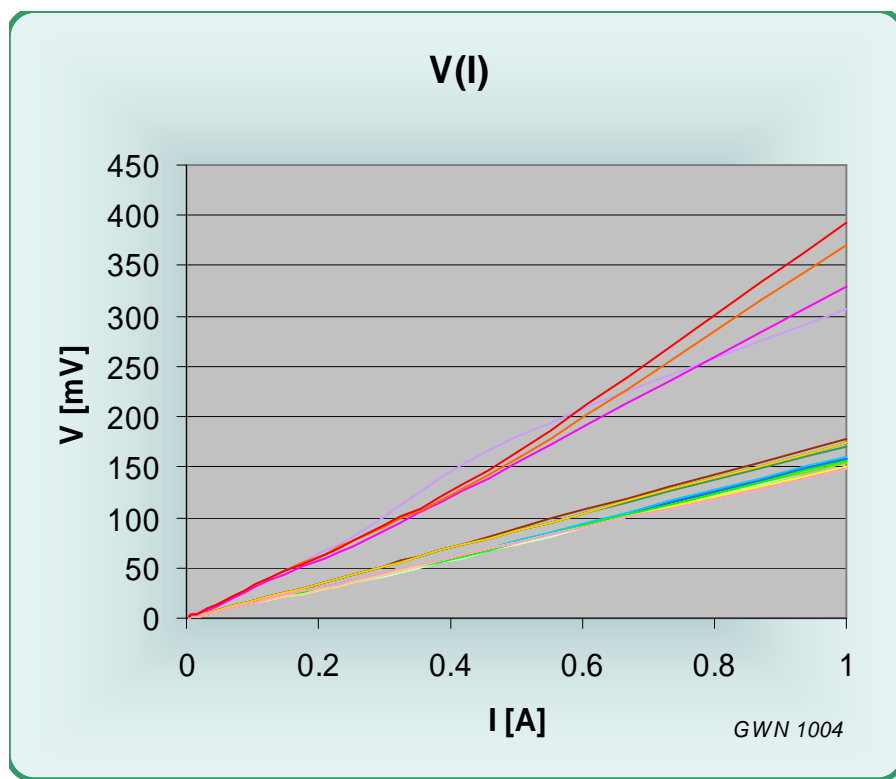
Figure 12 Voltage and resistance as a function of drive current

When measuring the current – voltage relationship for the CSP microstrip socket, the following responses were obtained (the color coding is identical to the previous graph):

There are no anomalies in this response. At one million cycles, resistance has increased. Damage to the contact under maximum rated drive current is not observed.

From the above graph it is possible to extract the resistance value at the corresponding drive current. Because of the absence of the strip under the socket and the resulting drive from the contact end, the current level was limited to 1A instead of the rated 4A to prevent damage. Values here are NOT corrected for the absence of a strip under the socket and therefore show a higher value than in the Cres measurement above. In reality the resistance level will be lower than shown in the following graphs. Therefore, this measurement is to be taken only as an indication of repeatability, NOT absolute resistance.

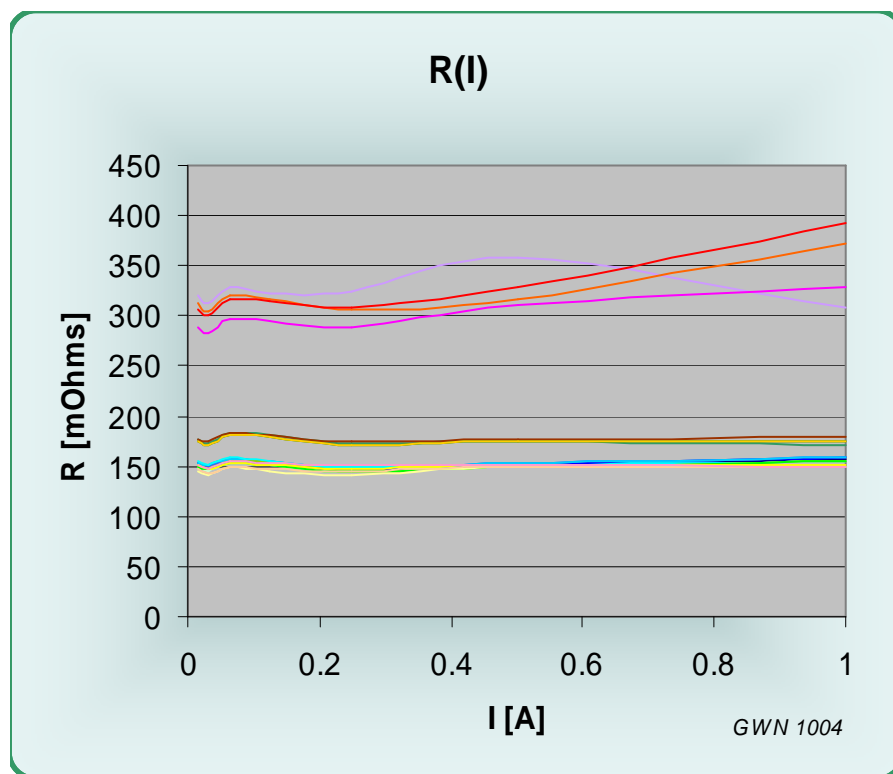
Figure 13 Resistance as a function of drive current

There are no significant changes of resistance with drive level. At current values below 20 mA the accuracy of the 10A current source is not sufficient to warrant extraction of resistance data.

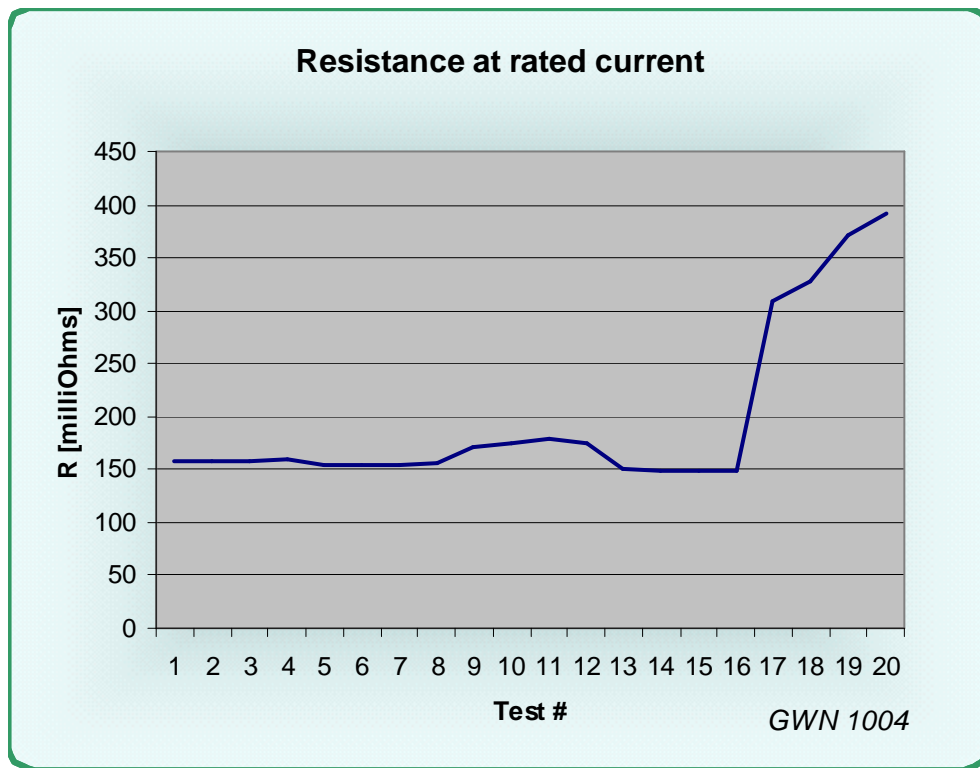
Figure 14 Resistance as a function of cycle # @ max. drive current

When plotting the resistance of the contact at 1A current as a function of cycle time, the following graph is obtained:

This graph shows no abnormal values. With increasing cycle number the overall resistance increases, but shows no irregularities. When comparing this to corresponding resistance values, it must be noted that the test numbers are not identical. In other words, these data are obtained after the socket has been tested in the resistance measurement sequence above. Hence, there will be no perfect correlation between these measurements and those obtained in the resistance measurement series.

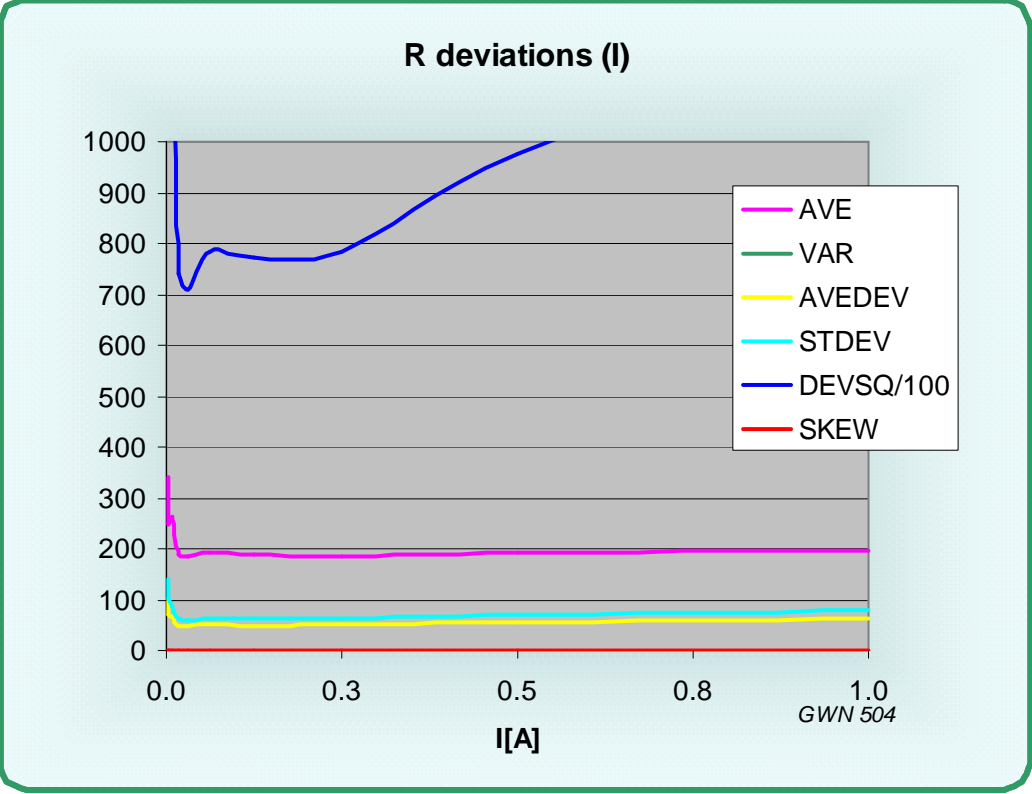
Figure 15 Deviations as a function of drive current

Statistical evaluation shows the following averages etc. as a function of drive current:

Definitions for the functions are given above. No abnormal values are present.

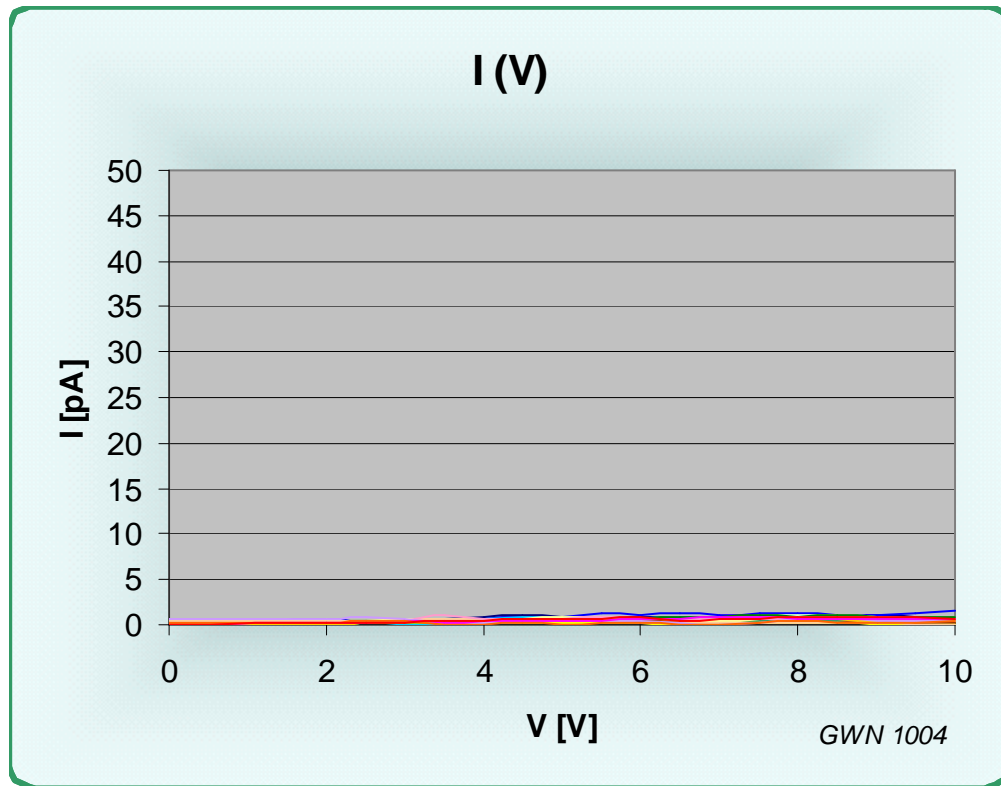
Figure 16 Leakage current as a function of drive voltage

To find any changes in the insulating performance socket materials and to identify any adverse contributions from debris accumulation, the leakage current was measured as a function of excitation voltage between the probe and all other test pins (ground):

Leakage is very low and is near the system limits of a few pA.

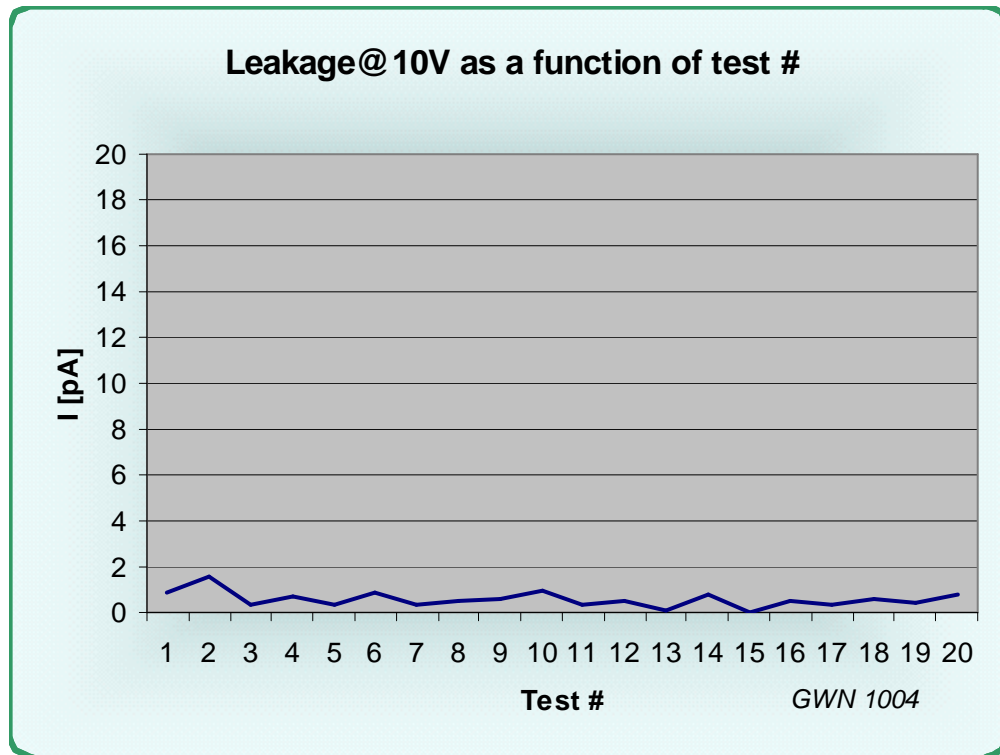
Figure 17 Leakage current @10V as a function of cycle #

Also of interest is the evolution of leakage with the number of test cycles. As such, the current observed at the 10 V excitation level is shown as a function of the test cycle number:

All values are within the system uncertainty. After the first four cycles an enhanced measurement technique was used. Values in the first four cycles are saddled with a greater system uncertainty, and hence may show larger leakage than actually present.

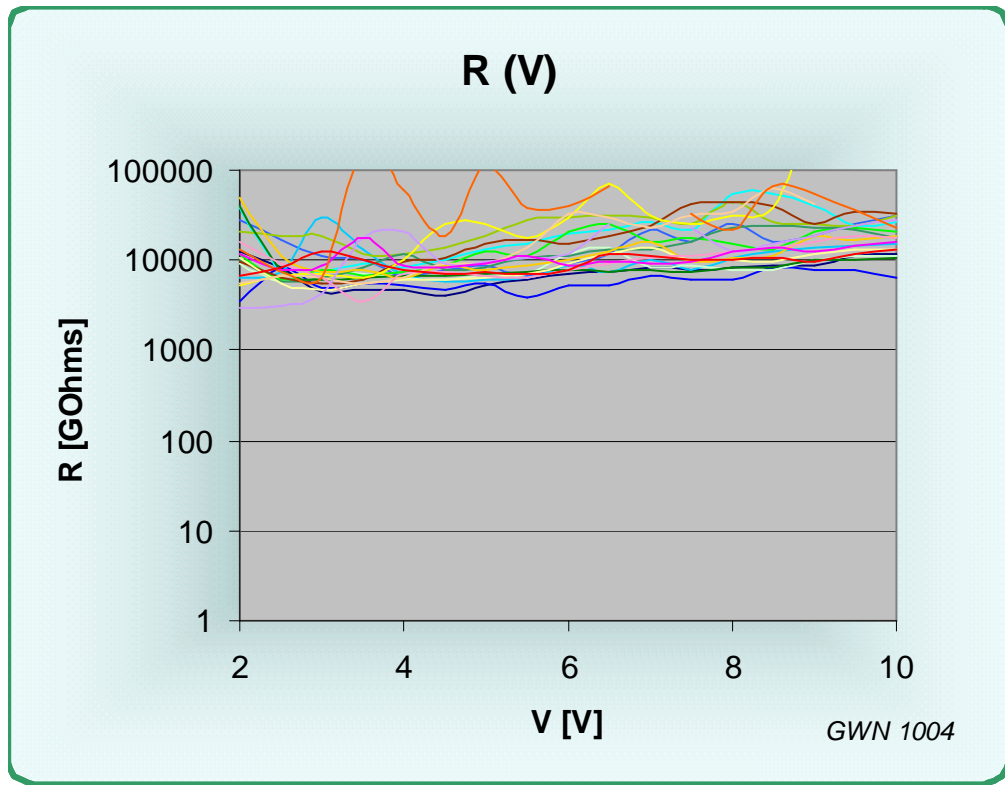
Figure 18 Leakage resistance as a function of drive voltage

When computing the corresponding resistance very large values result:

Total resistance values are very high and do not give any cause for concern. Values vary greatly, but of course all of them are at the very limit of the system capabilities.

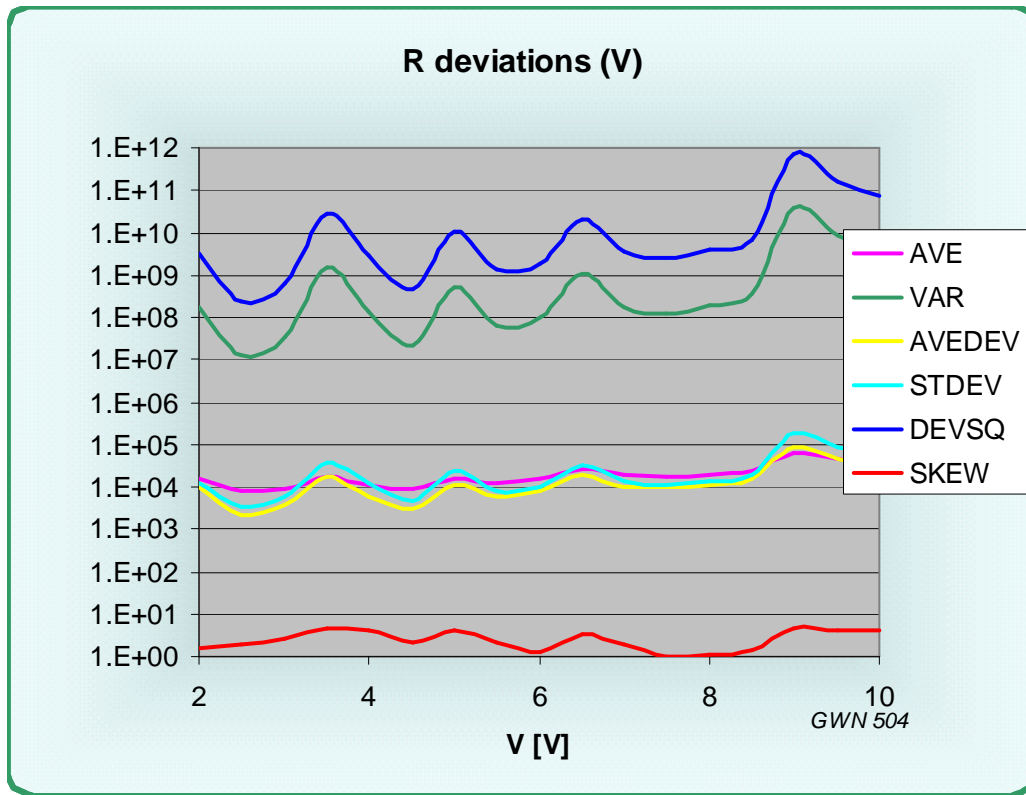
Figure 19 Leakage resistance variations as a function of voltage

Thus, it is somewhat difficult to consider deviations in an appropriate manner:

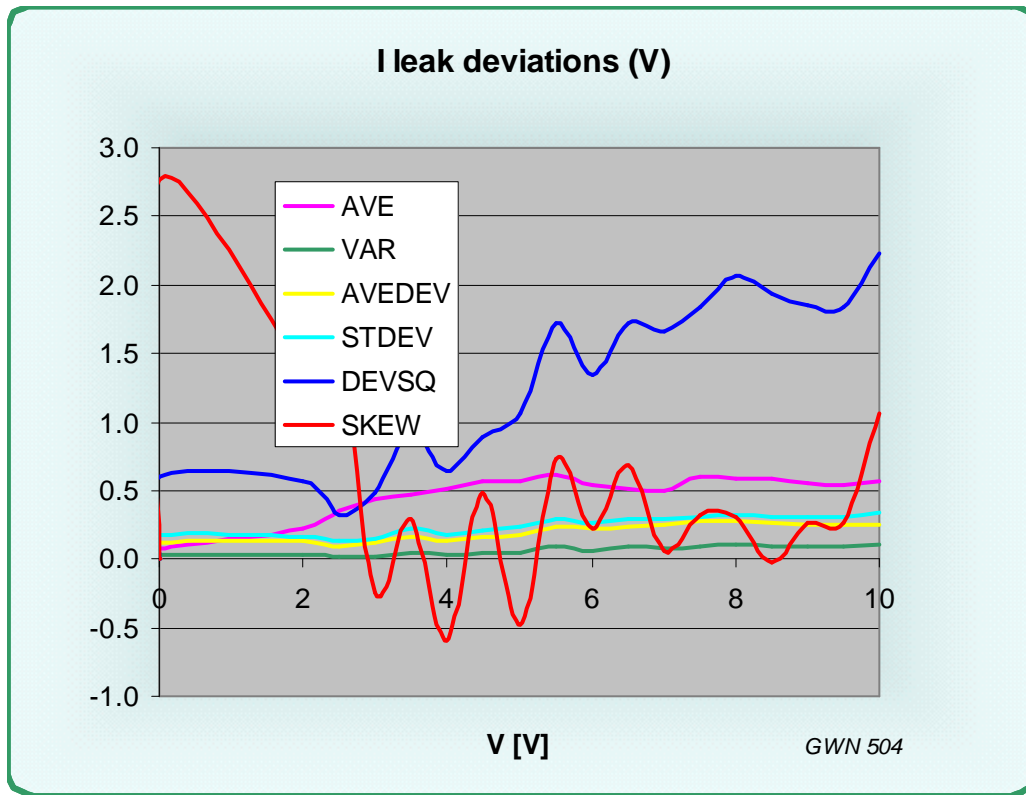
Figure 20 Leakage current variations as a function of voltage

Resistance variations will, of course be very large and it is thus perhaps better to consider leakage current statistics as shown below:

There are no anomalies in this response and no excess current is evident.

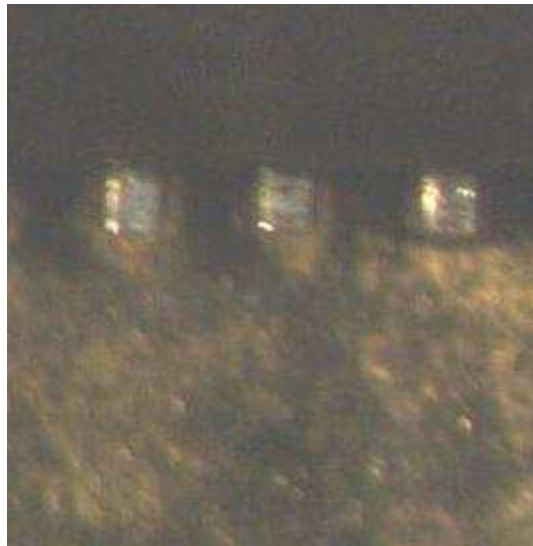
Figure 21 Contact tip appearance after the last stage of cycling (before cleaning)

During the cycling, small amounts of metal from the surrogate devices collected in the socket. Hence, sockets were periodically cleaned with a light brush to remove the larger loose particles. The picture below shows a view of the socket after the last stage (1M cycles total) and before cleaning:

The contact tips showed little wear despite the fact that the high number of cycles with the same surrogate device led to exposure of the underlying materials in the DUT.

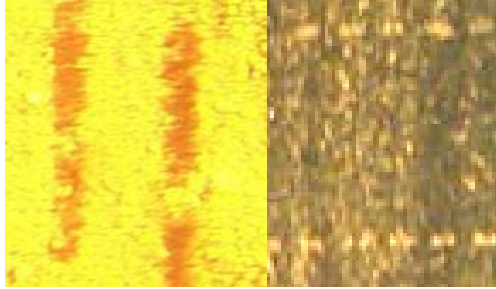
Figure 22 Base plate shows slight signs of wear

Also of interest were possible wear patterns caused by the contacts in the Au covered base plate. An image shows the area of that plate after the full complement of cycles. It should be noted that not only have the sockets been cycled to 1 million actuations, but also were mounted and demounted a large number of times on this plate.

A slightly visible wear pattern is discernible, likely caused by the socket strip contact pressing down on the plate during device insertion (left half of picture). Also noticeable are slight indentations at the rear end of the socket, where protrusions press into the base plate (right half of picture). Wear patterns in the surrogate device, of course, are very noticeable. This is not relevant to the socket assessment, however, since here surrogate devices were subjected to very large numbers of repeat insertions, a condition that does not reflect the operating environment found in the actual application.
