# Aries

QFP microstrip socket  
Cycling Test  
DC Measurement Results

Gert Hohenwarter

2/7/2005

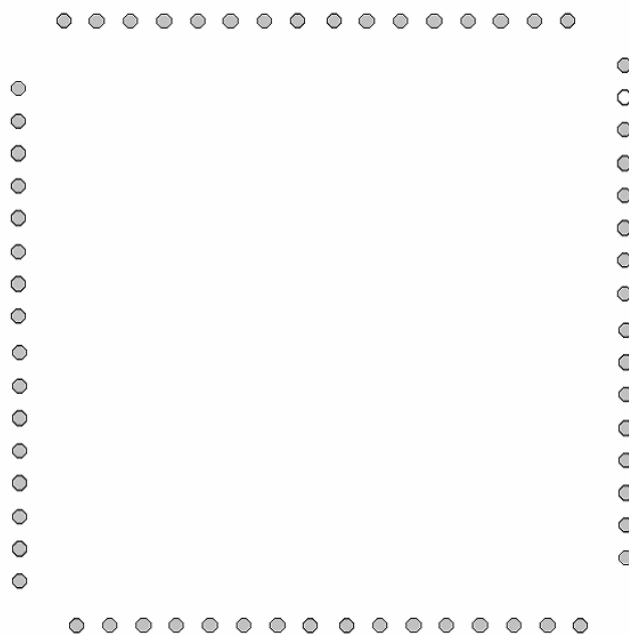
Figure 1 QFP socket test arrangement

To avoid any cross-effects from dc testing on RF characterizations, a different contact is used for this program. As shown in Fig. 1, the contact under test is on the side of the socket, typically the second from the top. The same contact will be used for all dc measurements, shown here in white.

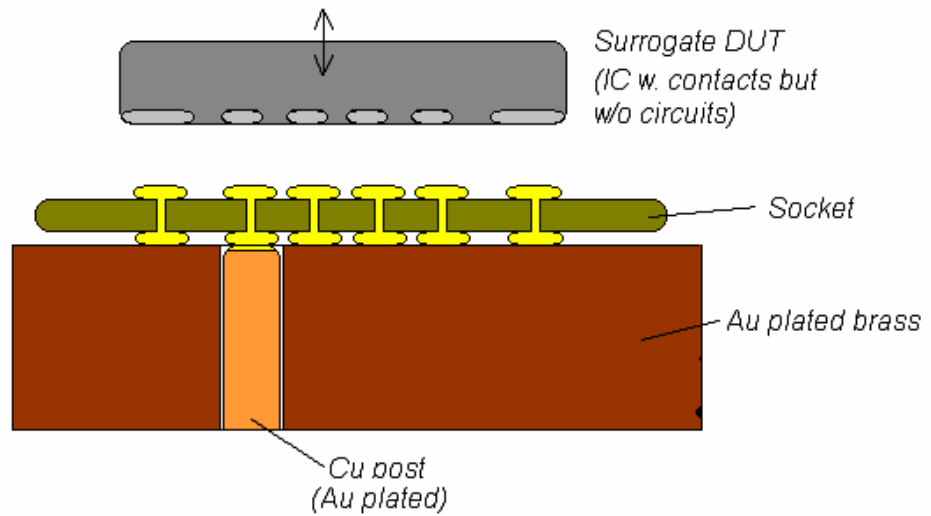
Figure 3 Cycling setup for socket testing

Two different types of cycling apparatus were used. Depending on the socket type either a mechanical cyler with parallel plates moving by a small amount or a solenoid based cyler were used. Displacement was typically established such that the surrogate test devices bottom out in the socket.

For the parallel plate setup force limiting was accomplished by inserting a thin hard rubber sheet between the DUT and the moving plates. Parameters were selected such that under maximum deflection and normal cycling conditions the surrogate device

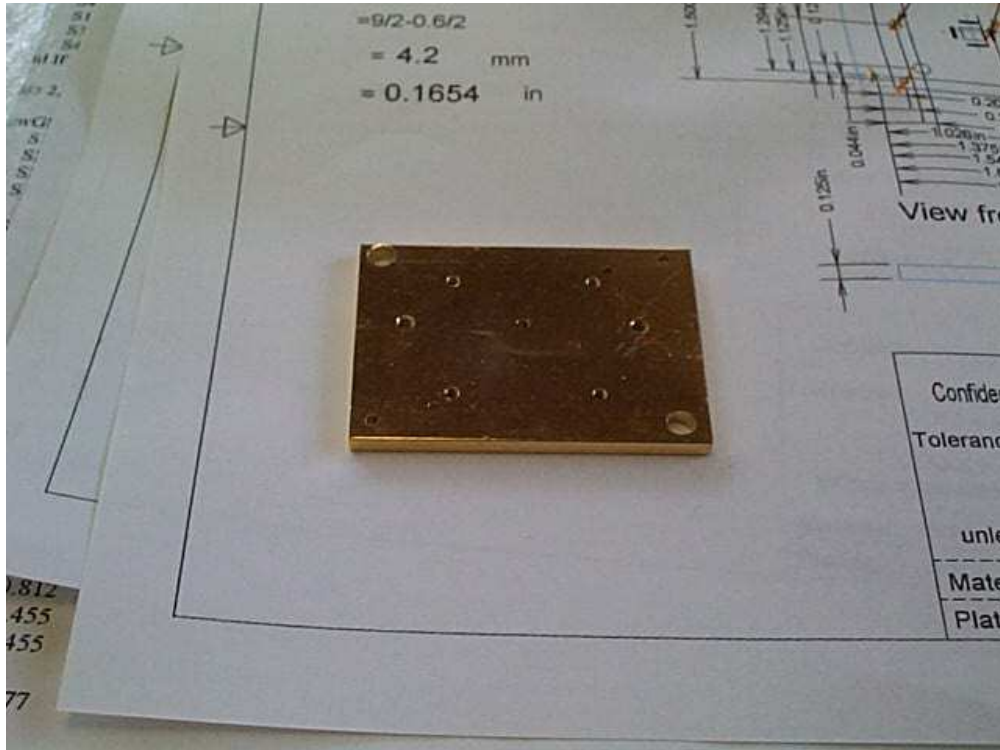
Figure 4 QFP socket mounting plate example

The socket is mounted on a brass plate similar to the one shown in Fig. 2. This plate has a small hole through which a probe is inserted for the dc testing. Since this plate is also used for mechanical cycling with surrogate devices, the probe bore is plugged with a metal plug during this procedure.

Au over Ni plating was applied to the surfaces of the brass plate. Material type and thickness specifications were identical to those used for PCBs.

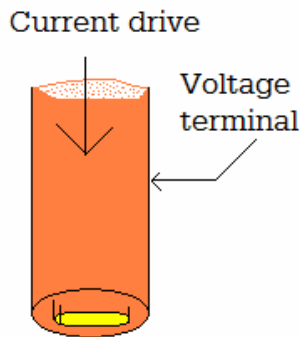
Figure 5 Current drive probe

The current/voltage probe consists of a copper post with suitably shaped surface. This surface is Ni and Au plated. The post has two connections, thus allowing for a four terminal measurement with very low residual resistance (about 1 milliOhm).

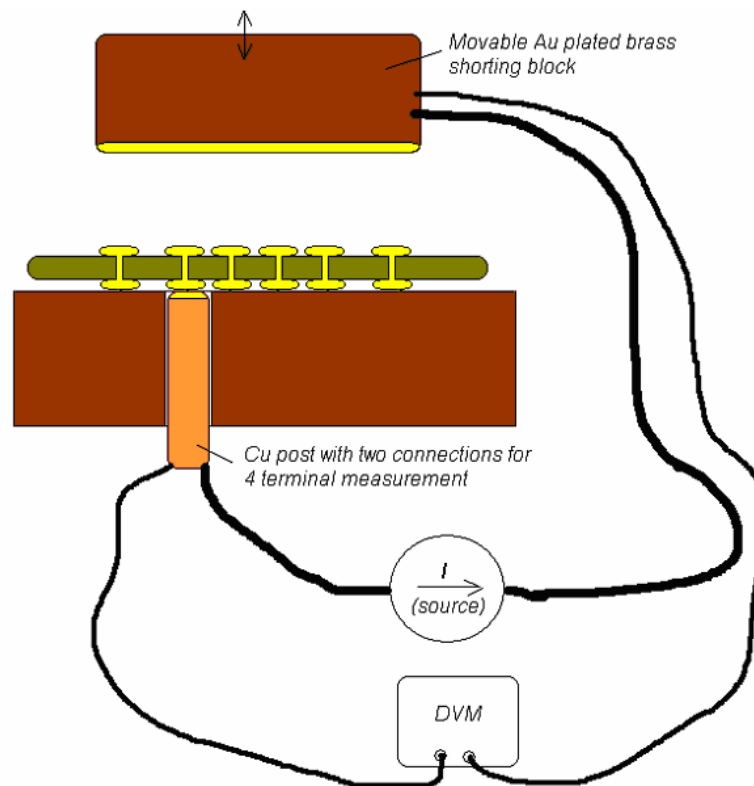
Figure 6 Test setup for 4 terminal (Kelvin) measurements

For current handling tests, all contacts are grounded except for one. The socket is then placed into the test setup. A brass plunger shaped like an actual test IC is pressed against the contacts on the DUT side of the socket. Au over Ni plating was applied to the surface of the plunger. A four terminal (Kelvin) measurement setup is used that included a computer controlled current source capable of delivering 10 A. The voltage developed across the contact is recorded at separate terminals with an HP3456A digital voltmeter. Once the data are available, they are processed to reveal the resistance and power dissipation as a function of drive current.

The same setup is used for contact resistance measurements. In this case, connections are made only to an HP3456A DMM. It is operated in 4 wire mode for this measurement. A precision linear potentiometer serves as a distance transducer. Its resistance is recorded by a second HP3456A DMM.

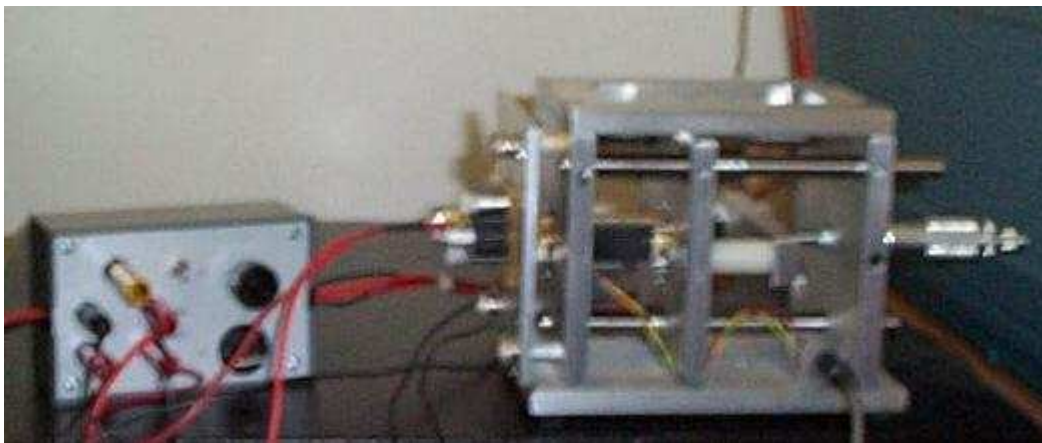
Figure 7 Test stand

The socket with its plate is mounted in a test stand with XYZ adjustment capability (Fig. 7).

This setup has a micrometer screw that allows repeatable adjustments in the Z direction. Also included is a transducer that converts Z position to an electrical signal for the data acquisition.

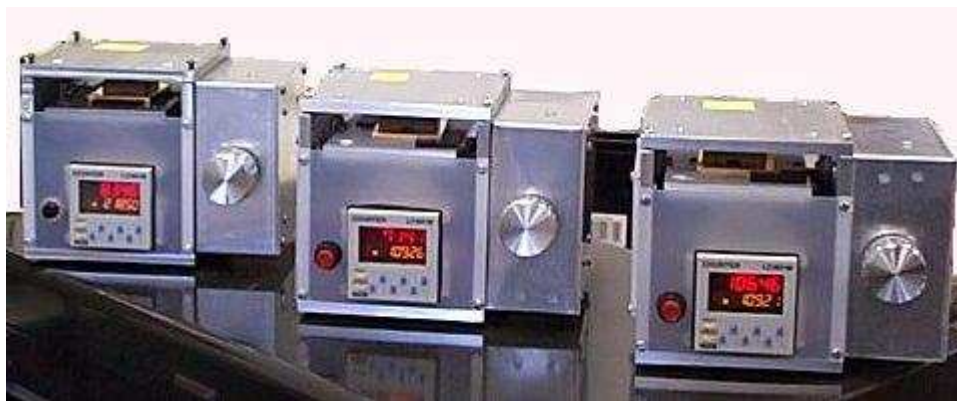
Figure 8 Parallel plate cyclers

touches the bottom of the socket. Where necessary, pressure sensitive paper was used to verify this condition. Maximum speed of this setup was 3 cycles per second.

When a solenoid based cycler was used, force limiting was via solenoid drive current when necessary. Force measurements were performed with a pressure indicating paper that is capable of determining the magnitude of the applied pressure and hence the force. This method is necessary because of the dynamic situation that exists with the solenoid plunger / surrogate chip holder assembly entering the DUT with some speed and hence contributing to the maximum force. Maximum operating speed was 10 cycles per second.

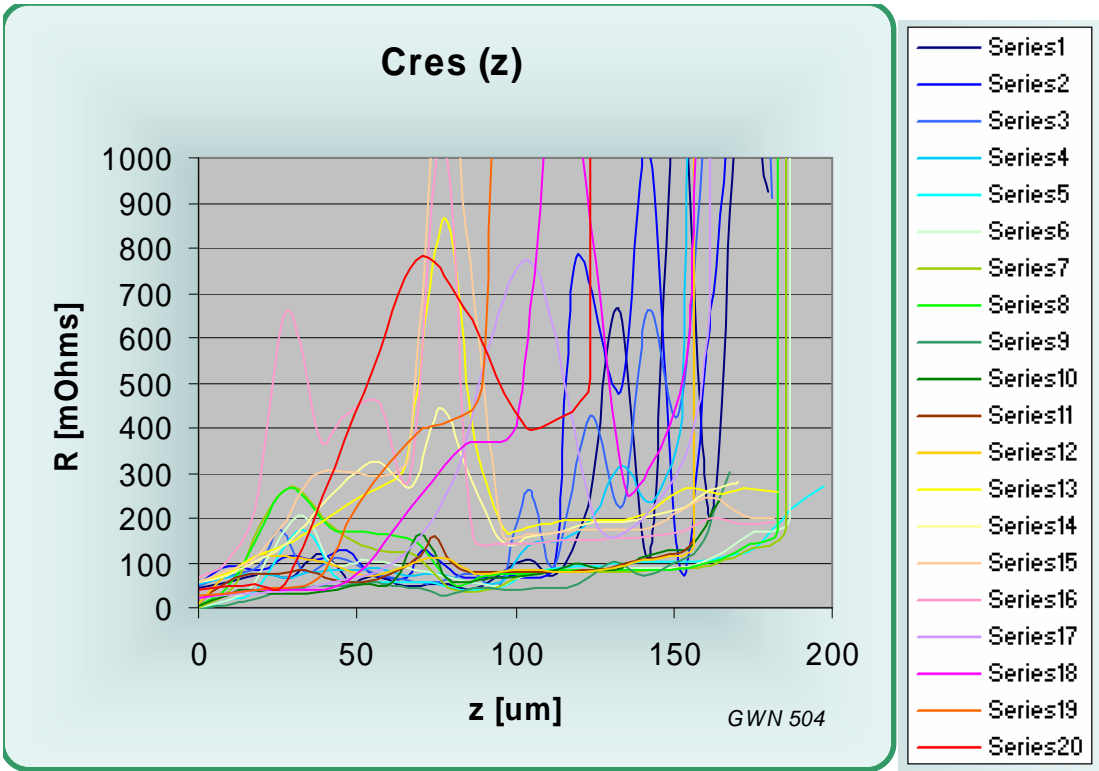
Figure 9 Contact resistance as a function of displacement

For this graph, the value z=0 represents the maximum compression in operation, i.e. with the DUT fully inserted. The results are corrected with the functional dependence of resistance as a function of displacement as obtained via regression during the cycle

0 test. A setup malfunction was detected during the initial portion of this test. An inadequate contact had been present between the socket and the 4-point test probe. This is evident in the large resistance excursions for tests 1-4 (blue curves). This was corrected after the first round of cycling. However, the initial measurements could, of course, not be recreated, since the socket had already undergone a number of DUT insertions. It may be assumed here, that the initial results in reality were better than those obtained for test numbers 5 and up. As cycle numbers increase ( $\Rightarrow$  series#), so does the overall resistance. It should be kept in mind here, that the resistance indicated includes contact resistance to the probe (=loadboard), the DUT, and the contact itself. For complex contact assemblies, this may be a significant contribution to the overall value.

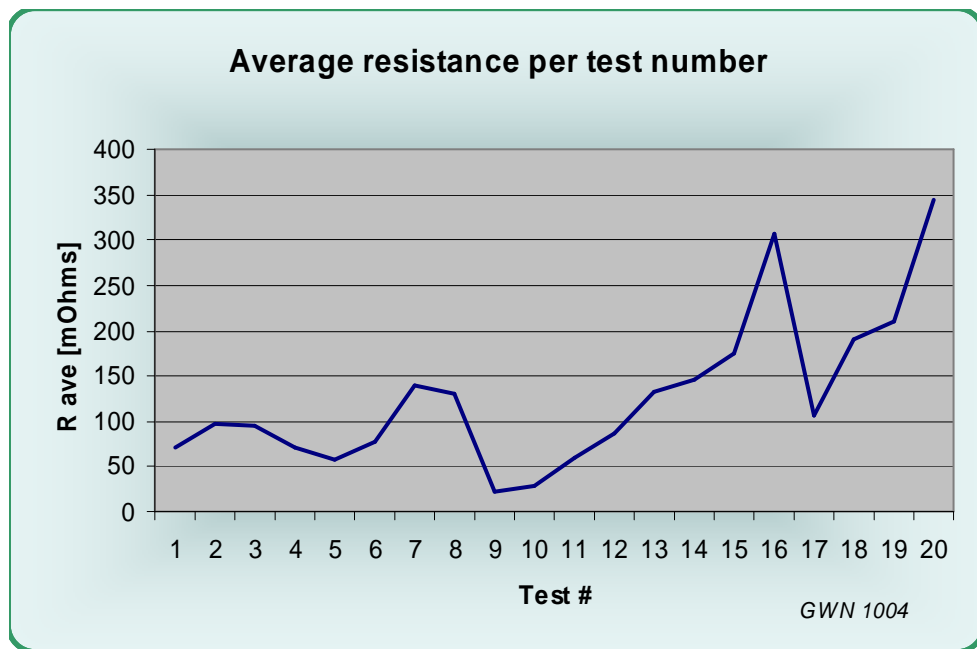
Figure 10 Contact resistance as a function of test number

As a measure of change throughout the cycles, the average resistance for the last 5 data points before the plunger reaches full insertion are plotted as a function of cycle number:

There is some resistance increase with increasing cycle numbers. It should be kept in mind, that the socket under test undergoes a number of matings/dematings with the test plates and probes. This may affect the backside contact of the socket and therefore the results shown.

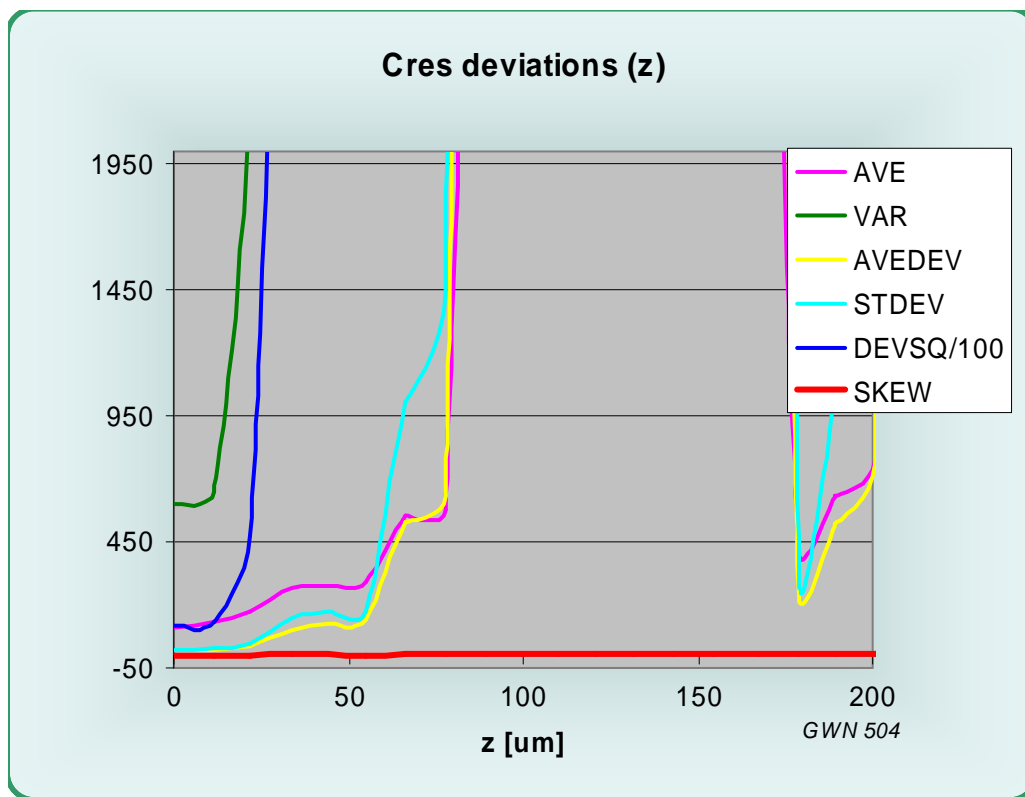
Figure 11 Statistics as a function of displacement

Also offered as a measure of contact performance are the deviations of the resistance as a function of displacement (plunger position, see graph below). Not surprisingly, average and variability increase when less displacement (force) is applied by the plunger.

The dataset used for the statistical function is the recorded resistance at a particular displacement for the cycles from 1-20. Data are then displayed for each displacement from minimum to maximum. The following definitions are used (from MS Excel):

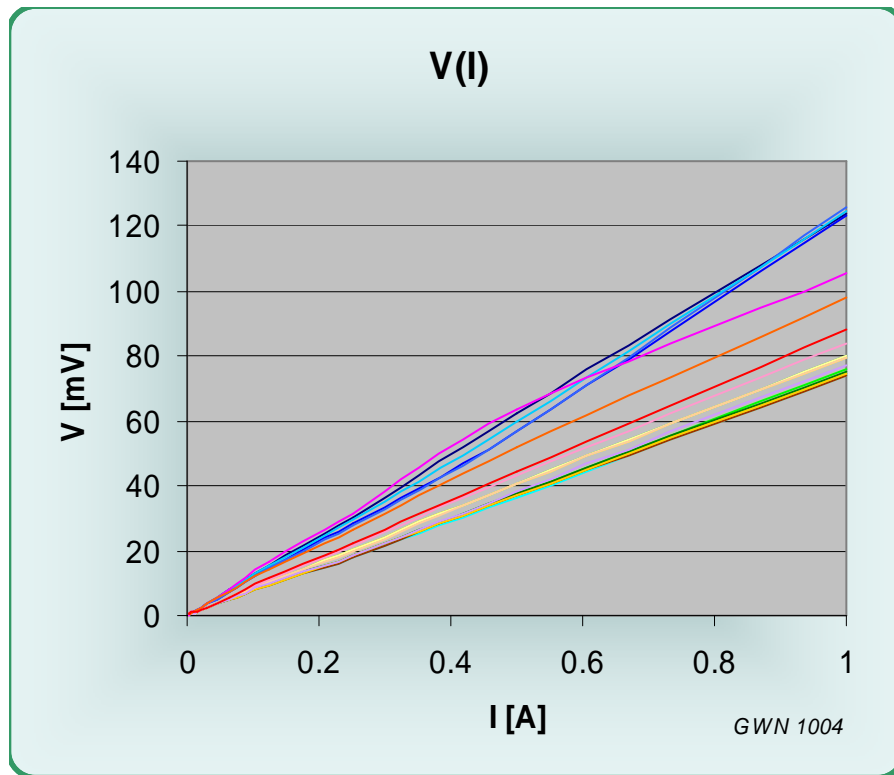
Figure 12 Voltage and resistance as a function of drive current

There are no anomalies in this response. At one million cycles, resistance has increased. Damage to the contact under maximum rated drive current is not observed.

From the above graph it is possible to extract the resistance value at the corresponding drive current. Because of the absence of the strip under the socket and the resulting drive from the contact end, the current level was limited to 1A instead of the rated 4A to prevent damage. Values here are NOT corrected for the absence of a strip under the socket and therefore show a higher value than in the Cres measurement above. In reality the resistance level will be lower than shown in the following graphs. Therefore, this measurement is to be taken only as an indication of repeatability, NOT absolute resistance.

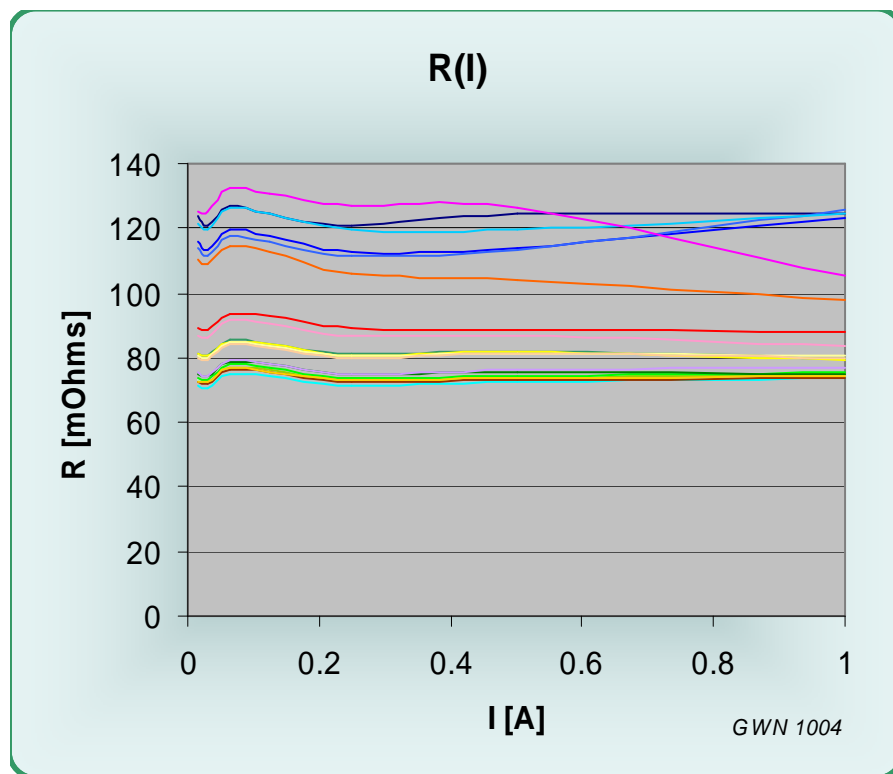
Figure 13 Resistance as a function of drive current

There are no significant changes of resistance with drive level. At current values below 20 mA the accuracy of the 10A current source is not sufficient to warrant extraction of resistance data.

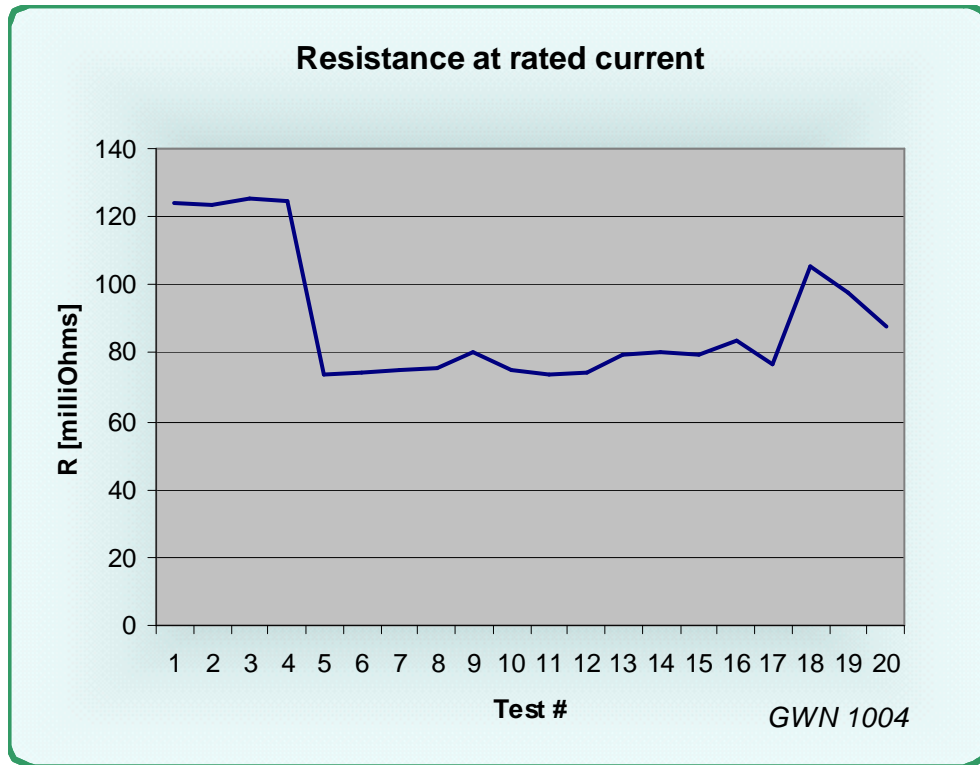
Figure 14 Resistance as a function of cycle # @ max. drive current

Again, this test was conducted WITHOUT a strip underneath the socket, so in reality resistance values will be significantly lower (see Cres results above). This graph shows no abnormal values. The drop after test #4 is due to the above mentioned setup malfunction. With increasing cycle number the overall resistance increases slightly, but shows no irregularities. When comparing this to corresponding resistance values, it must be noted that the test numbers are not identical. In other words, these data are obtained after the socket has been tested in the resistance measurement sequence above. Hence, there will be no perfect correlation between these measurements and those obtained in the resistance measurement series.

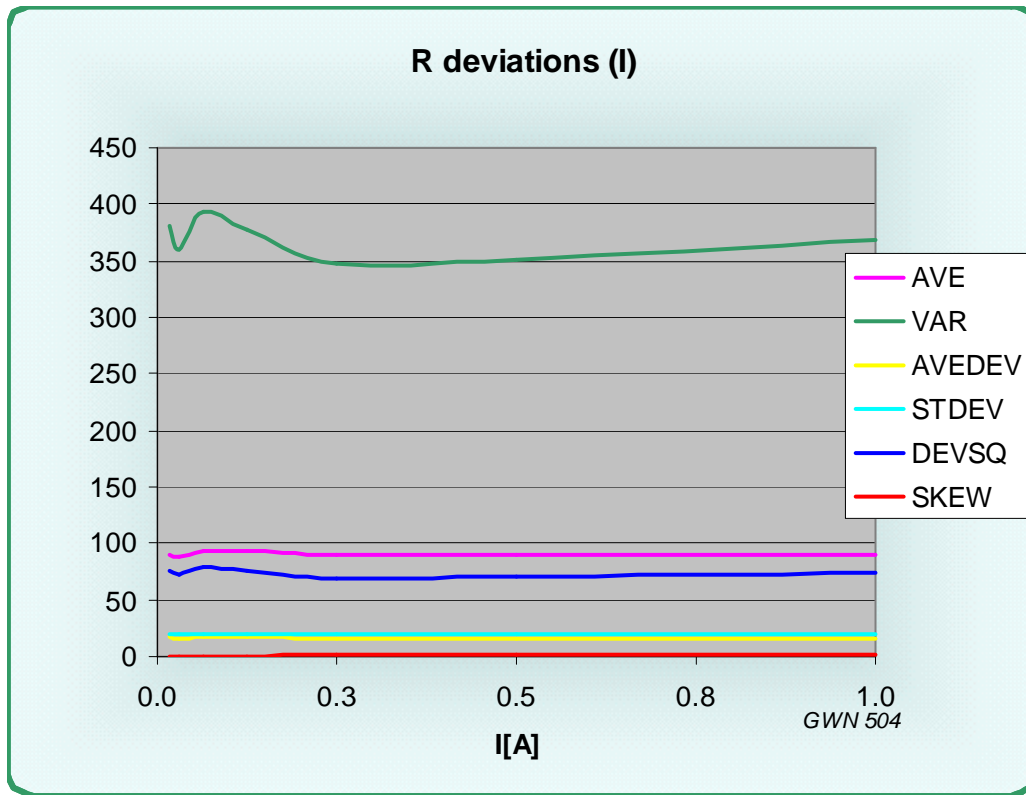
Figure 15 Deviations as a function of drive current

Definitions for the functions are given above. No abnormal values are present.

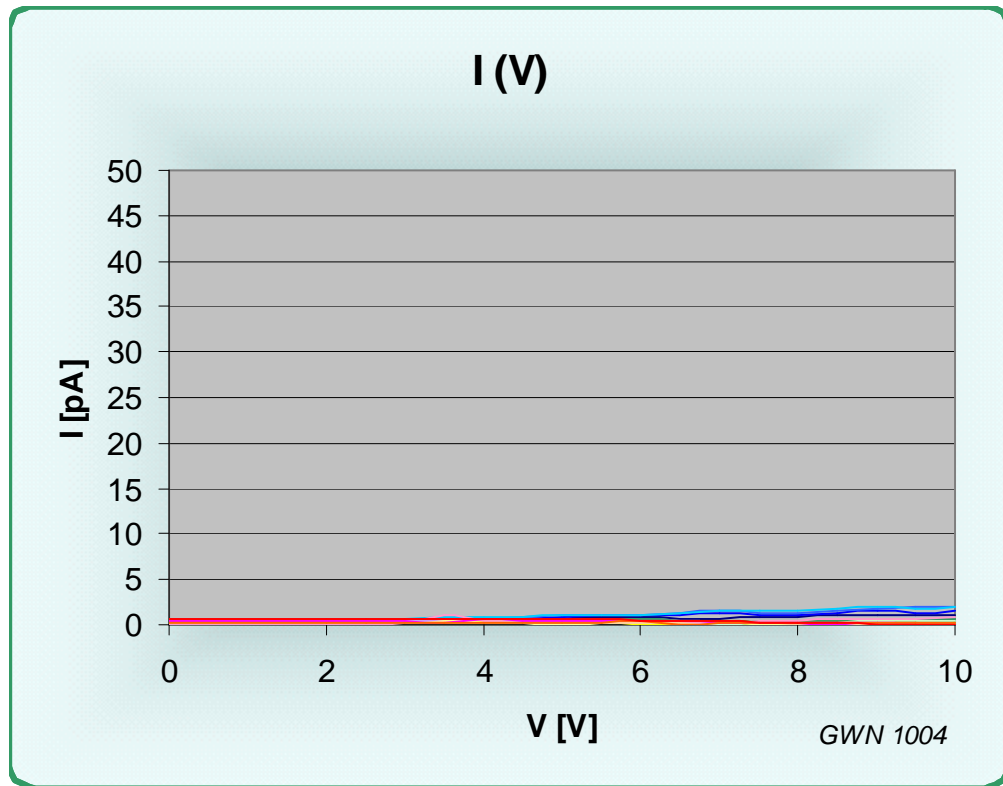
Figure 16 Leakage current as a function of drive voltage

To find any changes in the insulating performance socket materials and to identify any adverse contributions from debris accumulation, the leakage current was measured as a function of excitation voltage between the probe and all other test pins (ground):

Leakage is very low and is near the system limits of a few pA.

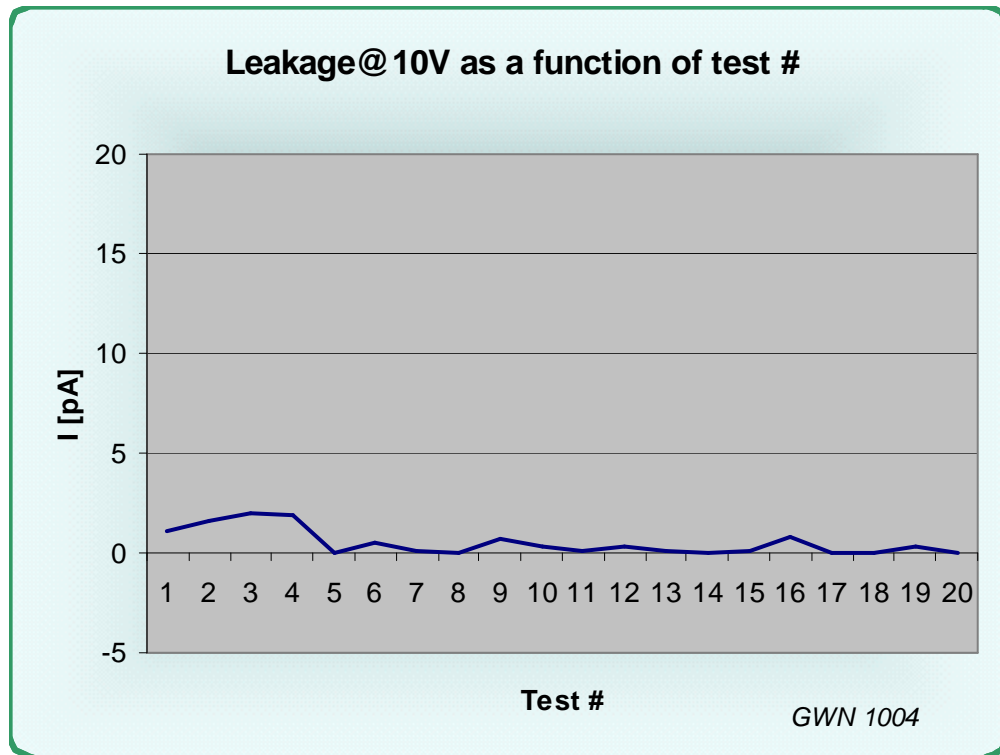
Figure 17 Leakage current @10V as a function of cycle #

Also of interest is the evolution of leakage with the number of test cycles. As such, the current observed at the 10 V excitation level is shown as a function of the test cycle number:

All values are within the system uncertainty. After the first four cycles an enhanced measurement technique was used. Values in the first four cycles are saddled with a greater system uncertainty, and hence may show larger leakage than actually present.

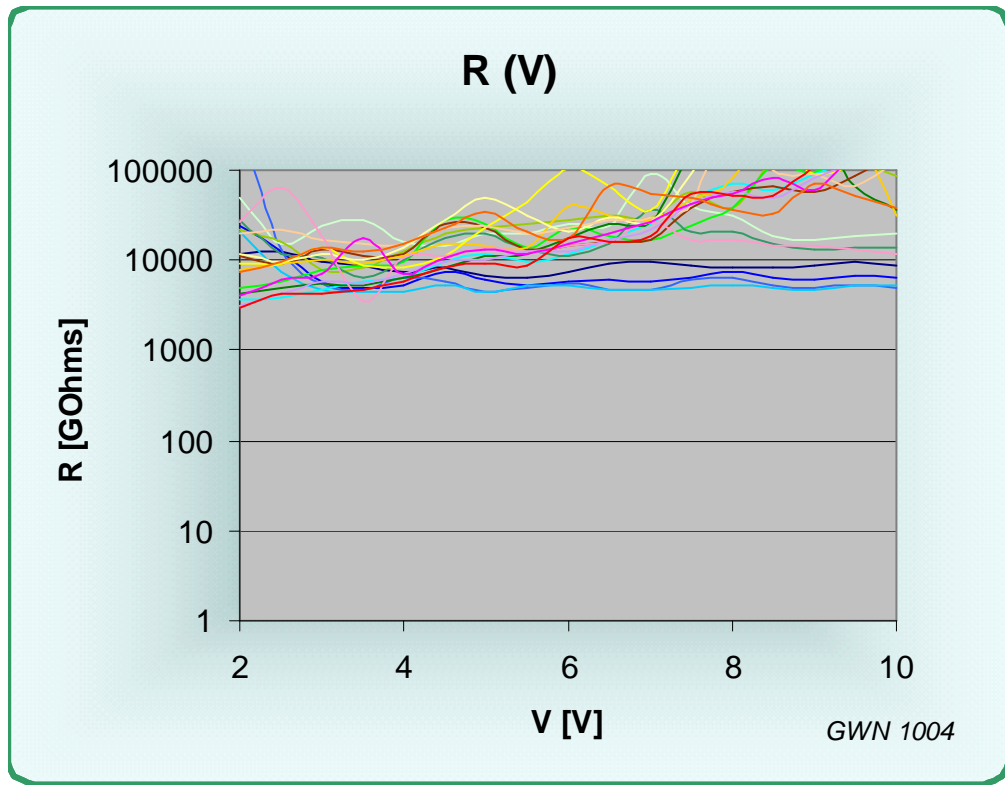
Figure 18 Leakage resistance as a function of drive voltage

Total resistance values are very high and do not give any cause for concern. Values vary greatly, but of course all of them are at the very limit of the system capabilities.

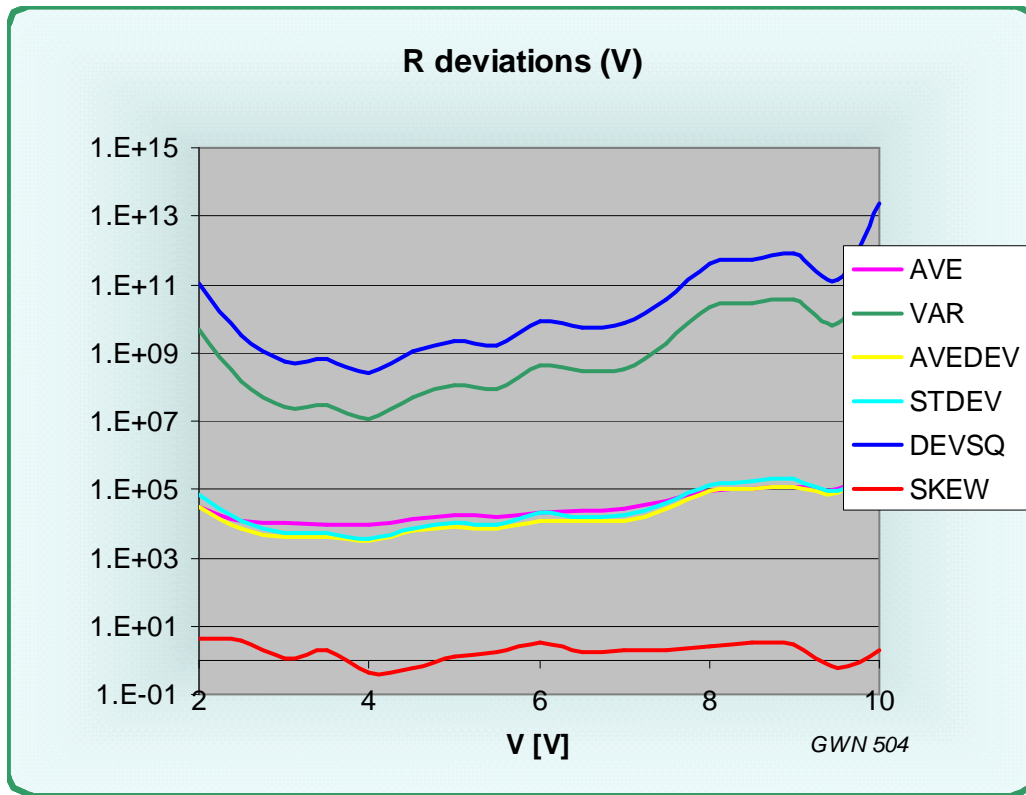
Figure 19 Leakage resistance variations as a function of voltage

Thus, it is somewhat difficult to consider deviations in an appropriate manner:

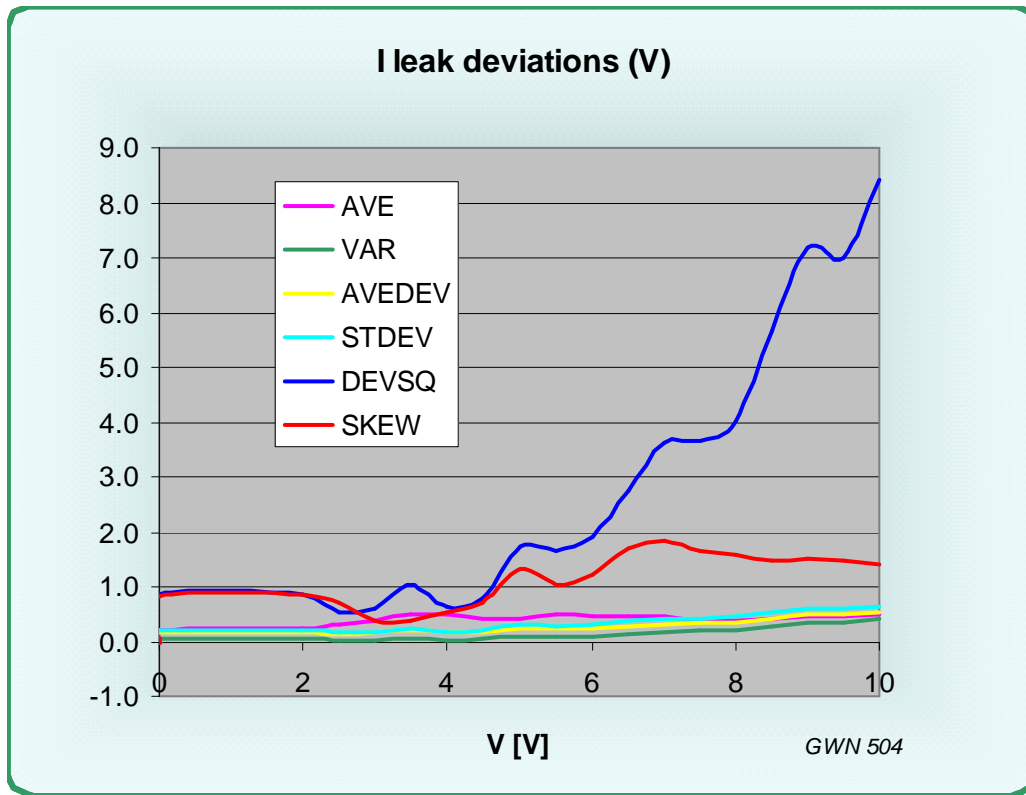
Figure 20 Leakage current variations as a function of voltage

Resistance variations will, of course be very large and it is thus perhaps better to consider leakage current statistics as shown below:

There are no anomalies in this response and no excess current is evident.

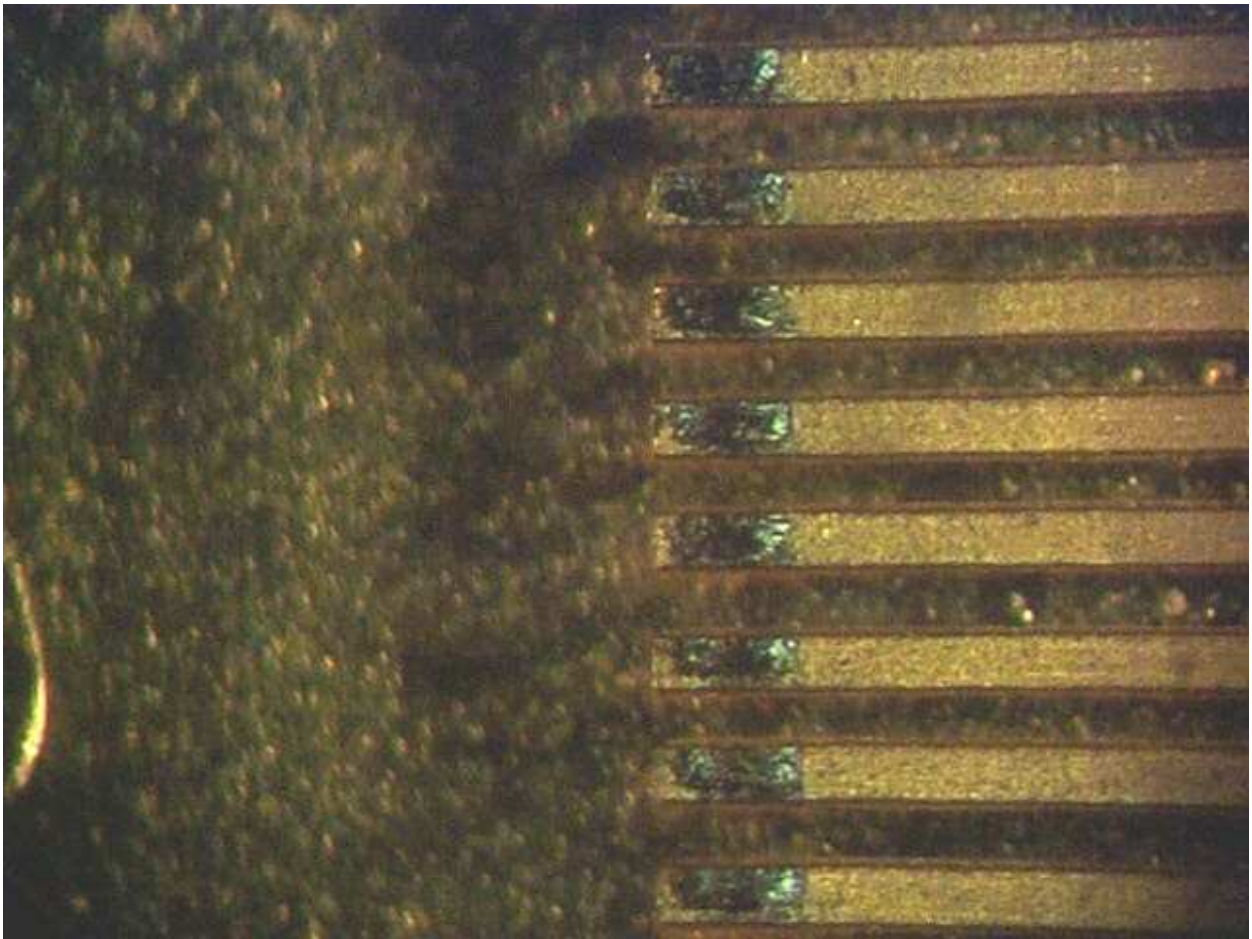
Figure 21 Contact tip appearance after the last stage of cycling (before cleaning)

During the cycling, small amounts of metal from the surrogate devices collected in the socket. Hence, sockets were periodically cleaned with a light brush to remove the larger loose particles. The picture below shows a view of the socket after the last stage (1M cycles total) and before cleaning:

The contact tips showed little wear despite the fact that the high number of cycles with the same surrogate device led to exposure of the underlying materials in the DUT.
