Aries

Kapton CSP socket
Cycling Test
DC Measurement Results

Gert Hohenwarter

10/27/2004

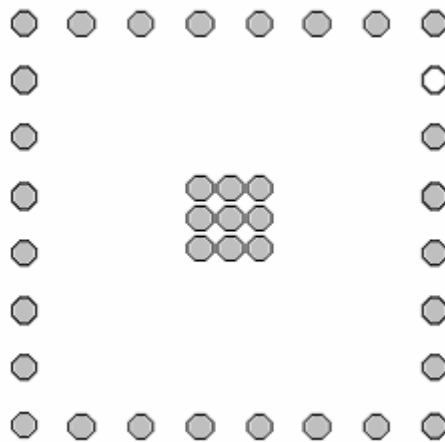
Figure 1 CSP socket test arrangement

To avoid any cross-effects from dc testing on RF characterizations, a different contact is used for this program. As shown in Fig. 1, the contact under test is on the side of the socket, typically the second from the top. The same contact will be used for all dc measurements, shown here in white.

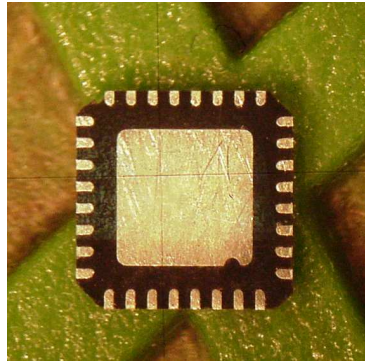
Figure 2 Surrogate IC

The probe CSP socket is mounted on a brass plate similar to the one shown in Fig. 2. This plate has a small hole through which a probe is inserted for the dc testing. Since this plate is also used for mechanical cycling with surrogate devices, the probe bore is plugged with a metal plug during this procedure.

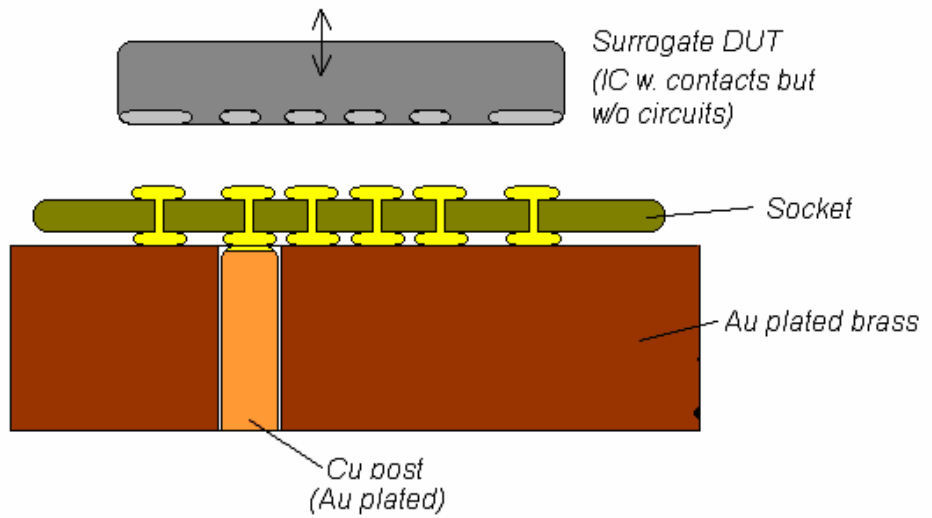
Figure 3 Cycling setup for socket testing

Sketches of the setups used during load cycling and testing are shown in the figures below:

Two different types of cycling apparatus were used. Depending on the socket type either a mechanical cyler with parallel plates moving by a small amount or a solenoid based cyler were used. Displacement was typically established such that the surrogate test devices reach a position close to bottoming out in the socket.

For the parallel plate setup force limiting was accomplished by inserting a thin hard rubber sheet between the DUT and the moving plates. Parameters were selected such that under maximum deflection and normal cycling conditions the surrogate device

touches the bottom of the socket. Where necessary, pressure sensitive paper was used to verify this condition. Maximum speed of this setup was 3 cycles per second.

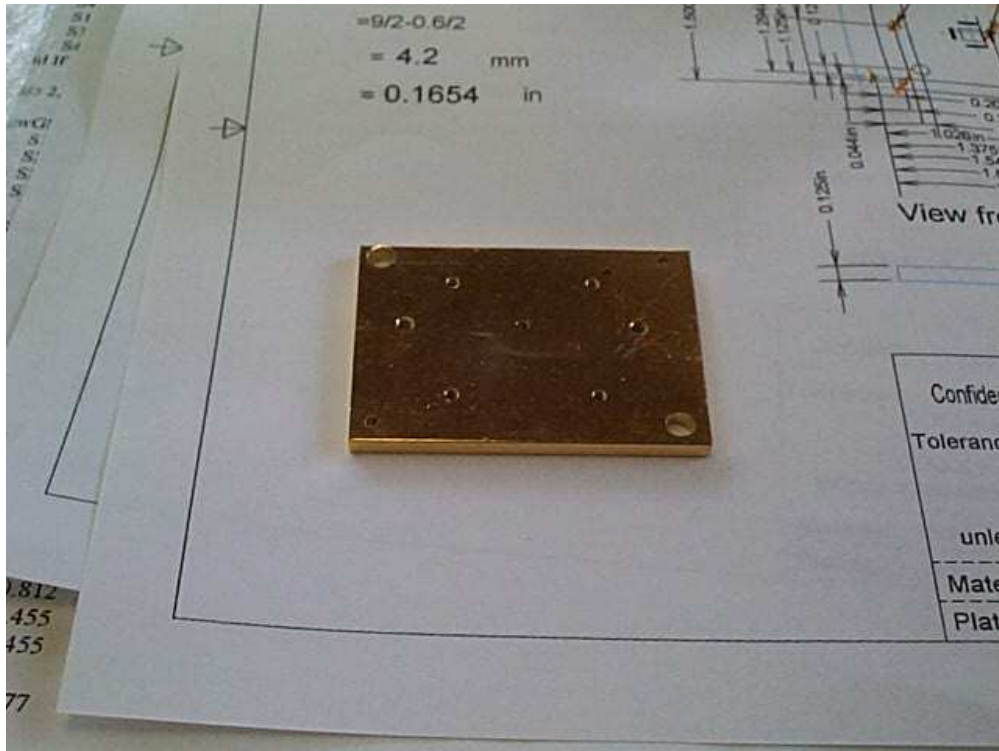
Figure 4 Kapton CSP socket mounting plate example

Au over Ni plating was applied to the surfaces of the brass plate. Material type and thickness specifications were identical to those used for PCBs.

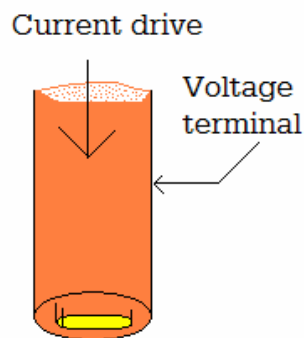
Figure 5 Current drive probe

The current/voltage probe consists of a copper post with suitably shaped surface. This surface is Ni and Au plated. The post has two connections, thus allowing for a four terminal measurement with very low residual resistance (about 1 milliOhm).

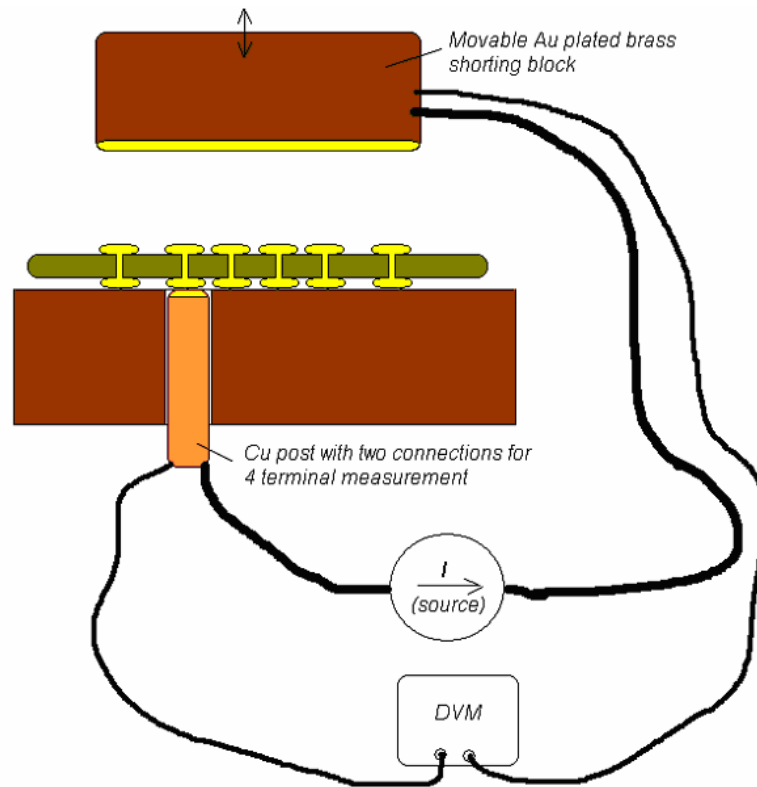
Figure 6 Test setup for 4 terminal (Kelvin) measurements

For current handling tests, all contacts are grounded except for one. The probe CSP socket is placed into the test setup. A brass plunger shaped like an actual test IC is pressed against the contacts on the DUT side of the socket. Au over Ni plating was applied to the surface of the plunger. A four terminal (Kelvin) measurement setup is used that included a computer controlled current source capable of delivering 10 A. The voltage developed across the contact is recorded at separate terminals with an HP3456A digital voltmeter. Once the data are available, they are processed to reveal the resistance and power dissipation as a function of drive current.

The same setup is used for contact resistance measurements. In this case, connections are made only to an HP3456A DMM. It is operated in 4 wire mode for this measurement. A precision linear potentiometer serves as a distance transducer. Its resistance is recorded by a second HP3456A DMM.

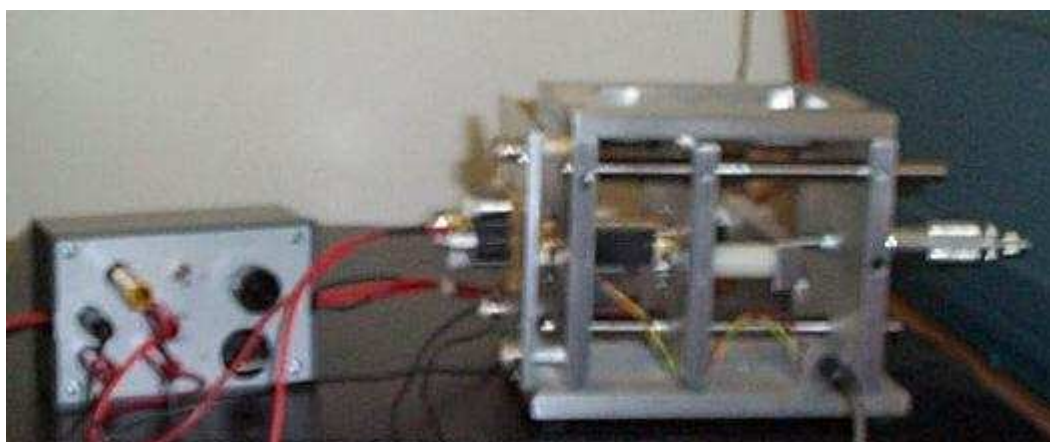
Figure 7 Test stand

The socket with its plate is mounted in a test stand with XYZ adjustment capability (Fig. 7).

This setup has a micrometer screw that allows repeatable adjustments in the Z direction. Also included is a transducer that converts Z position to an electrical signal for the data acquisition.

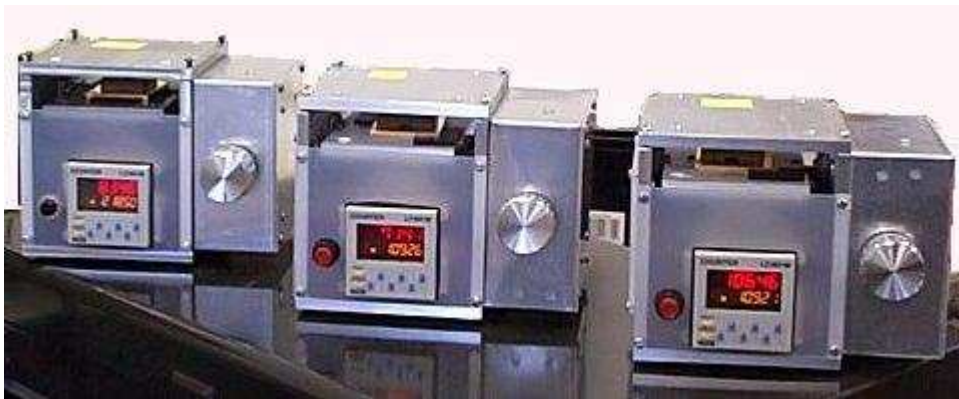
Figure 8 Parallel plate cyclers

When a solenoid based cycler was used, force limiting was via solenoid drive current when necessary. Force measurements were performed with a pressure indicating paper that is capable of determining the magnitude of the applied pressure and hence the force. This method is necessary because of the dynamic situation that exists with the solenoid plunger / surrogate chip holder assembly entering the DUT with some speed and hence contributing to the maximum force. Maximum operating speed was 10 cycles per second.

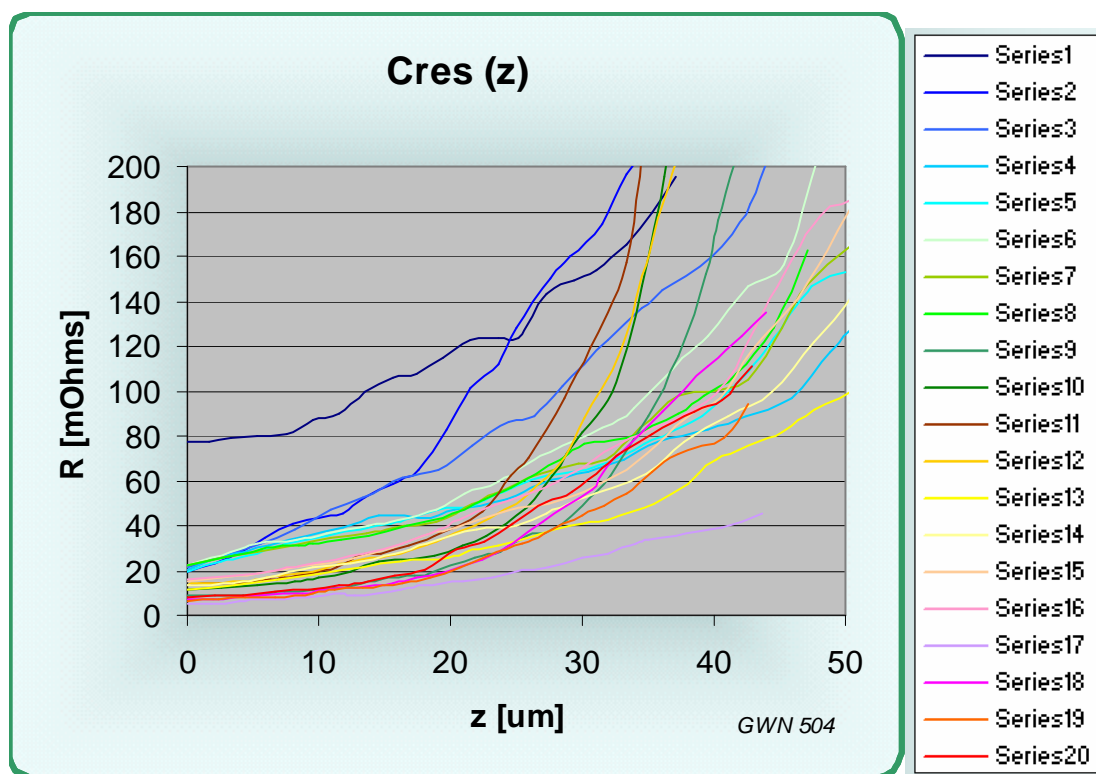
Figure 9 Contact resistance as a function of displacement

For this graph, the value $z=0$ represents the maximum compression in operation, i.e. with the DUT fully inserted. There are no anomalies in the observed response. As cycle numbers increase (\Rightarrow series#), so does the overall resistance. It should be kept

in mind here, that the resistance indicated includes contact resistance to the probe (=loadboard), the DUT, and the contact itself. For complex contact assemblies, this may be a significant contribution to the overall value.

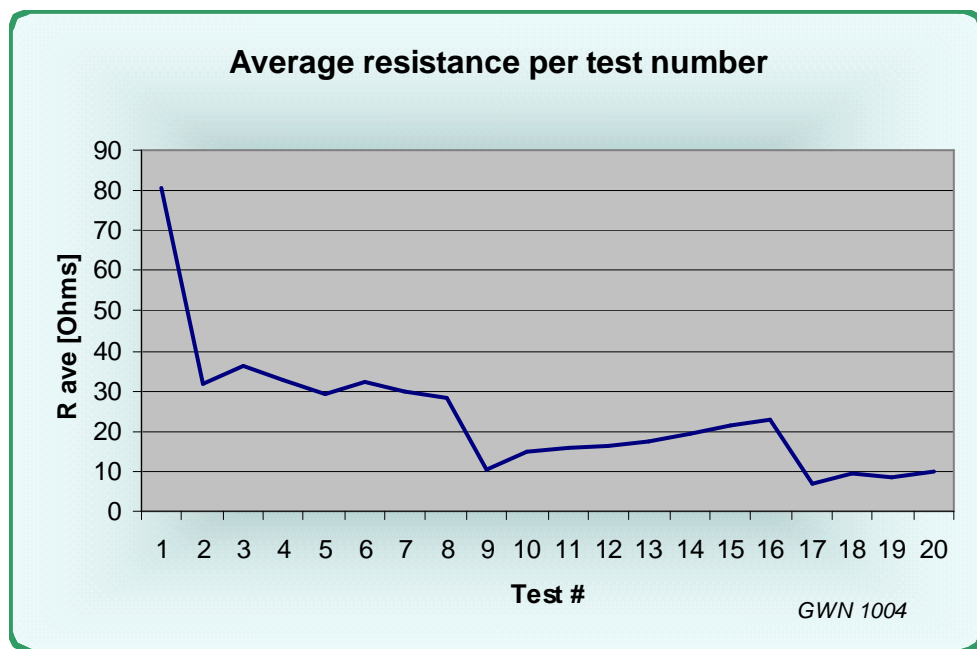
Figure 10 Contact resistance as a function of cycle number

As a measure of change throughout the cycles, the average resistance for the last 5 data points before the plunger reaches full insertion are plotted as a function of test number:

While there is some variation, the overall level is quite stable and even decreases as the number of DUT insertions rises. It must also be kept in mind, that the socket under test undergoes a number of matings/dematings with the test plates and probes. This may affect the backside contact of the socket and the results shown.

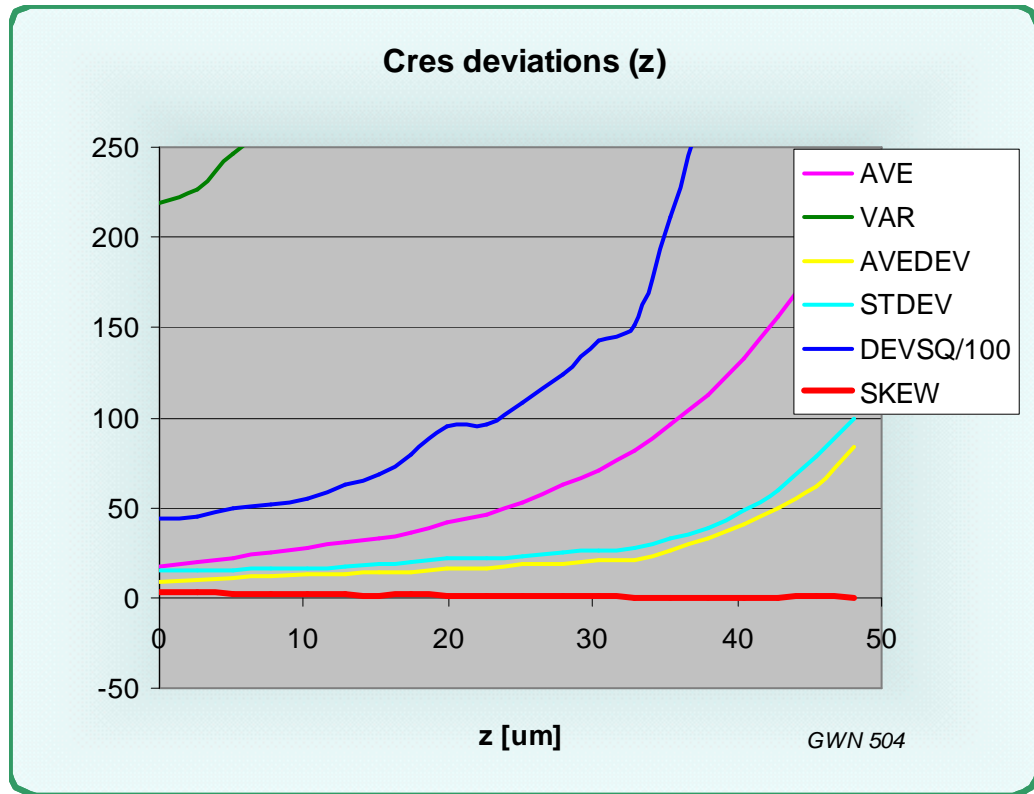
Figure 11 Statistics as a function of displacement

Also offered as a measure of contact performance are the deviations of the resistance as a function of displacement (plunger position, see graph below). Not

surprisingly, average and variability increase when less displacement (force) is applied by the plunger.

The dataset used for the statistical function is the recorded resistance at a particular displacement for the cycles from 1-20. Data are then displayed for each displacement from minimum to maximum. The following definitions are used (from MS Excel):

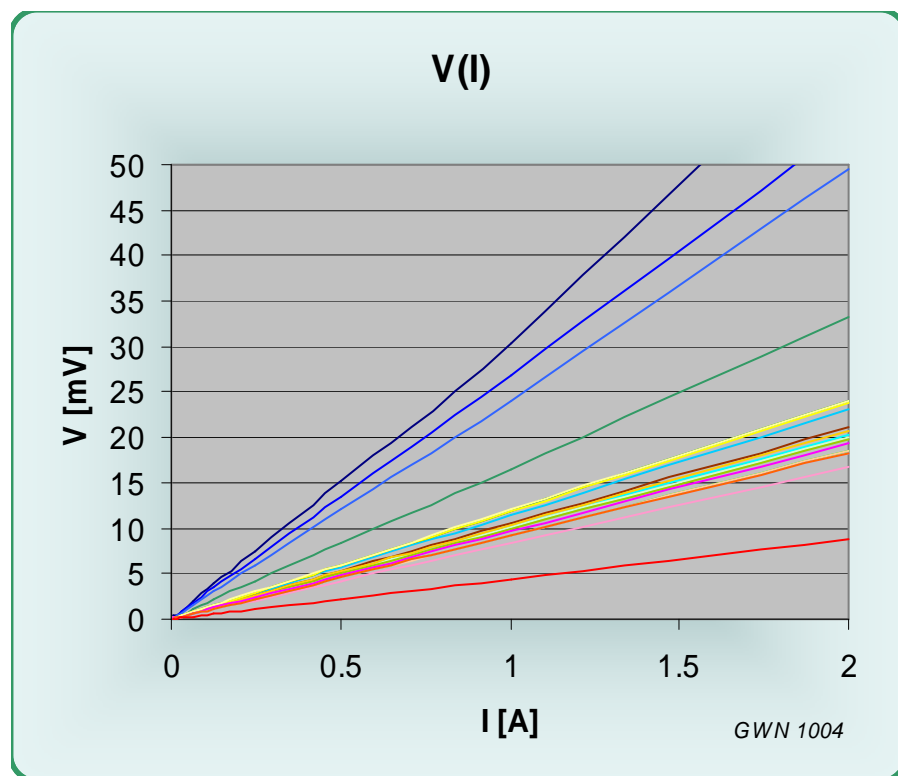
Figure 12 Voltage and resistance as a function of drive current

When measuring the current – voltage relationship for the Kapton CSP socket one obtains the following responses (the color coding is identical to the previous graph):

There are no anomalies in this response. Damage to the contact under maximum rated drive current is not observed.

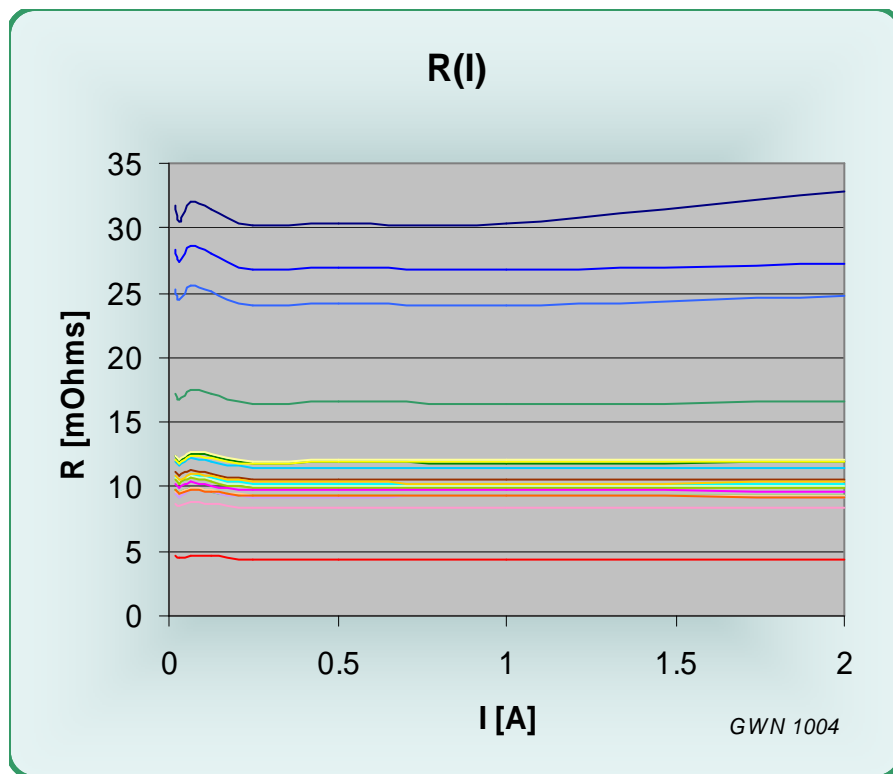
Figure 13 Resistance as a function of drive current

There are no significant changes of resistance with drive level. At current values below 20 mA the accuracy of the 10A current source is not sufficient to warrant extraction of resistance data.

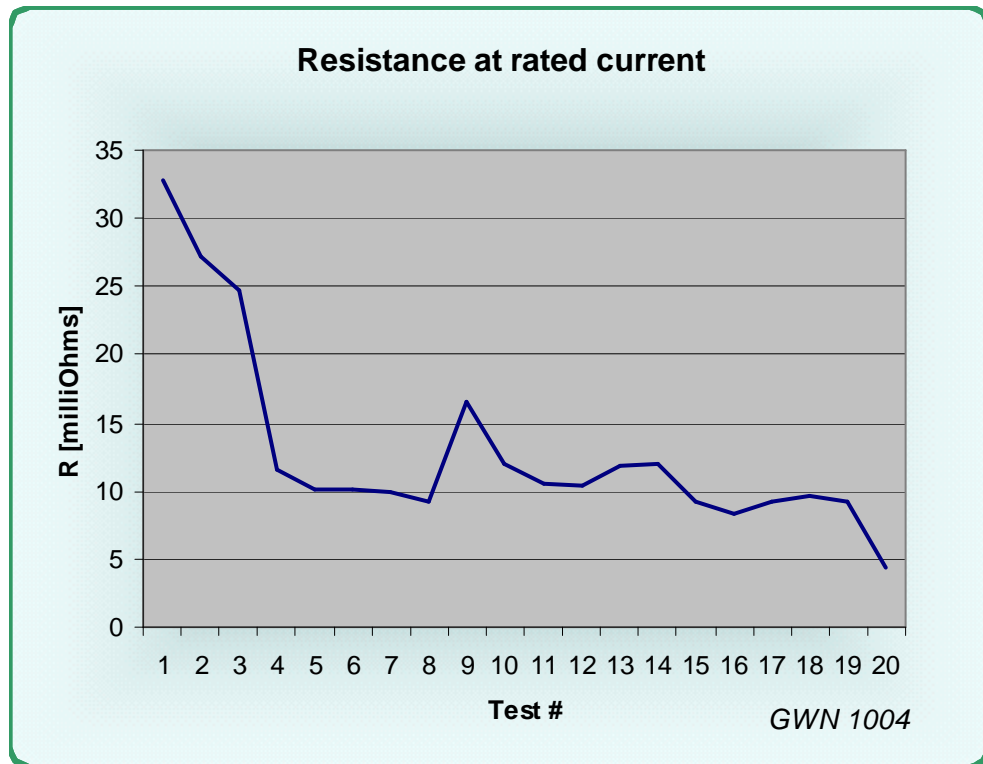
Figure 14 Resistance as a function of test # @ max. drive current

This graph shows no abnormal values. With increasing cycle number the overall resistance decreases somewhat, but shows no irregularities. When comparing this to corresponding resistance values, it must be noted that the cycle numbers are not identical. In other words, these data are obtained after the socket has been tested in the resistance measurement sequence above. Hence, there will be no perfect correlation between these measurements and those obtained in the resistance measurement series.

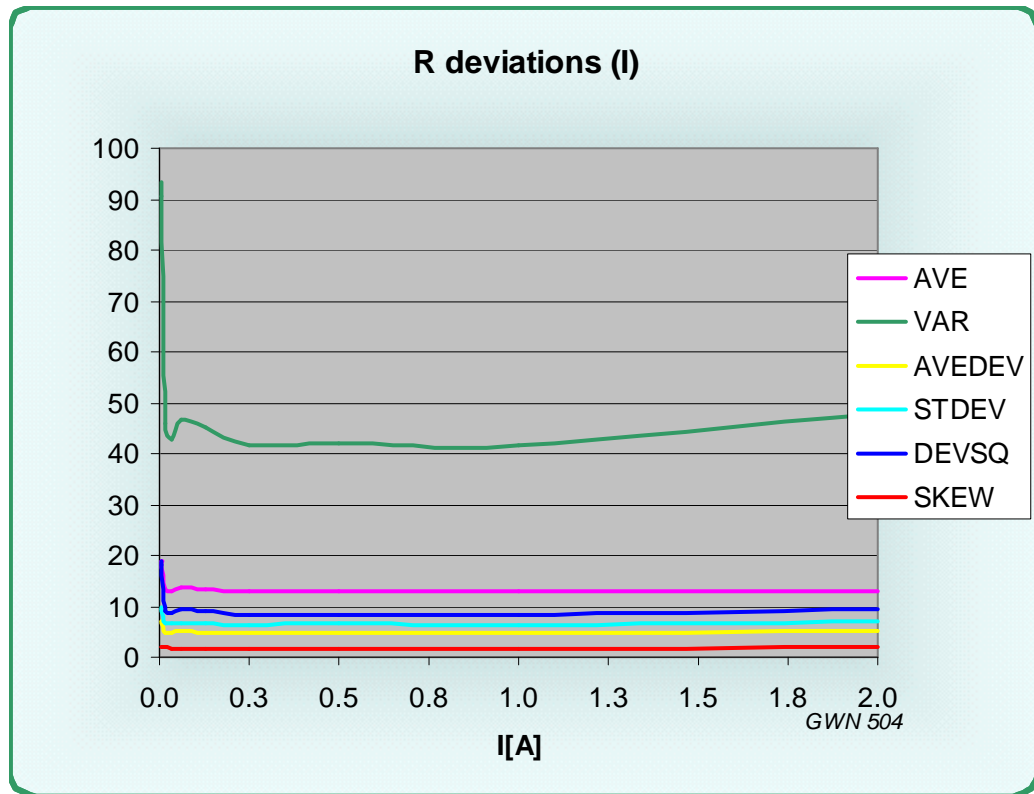
Figure 15 Deviations as a function of drive current

Definitions for the functions are given above. No abnormal values are present.

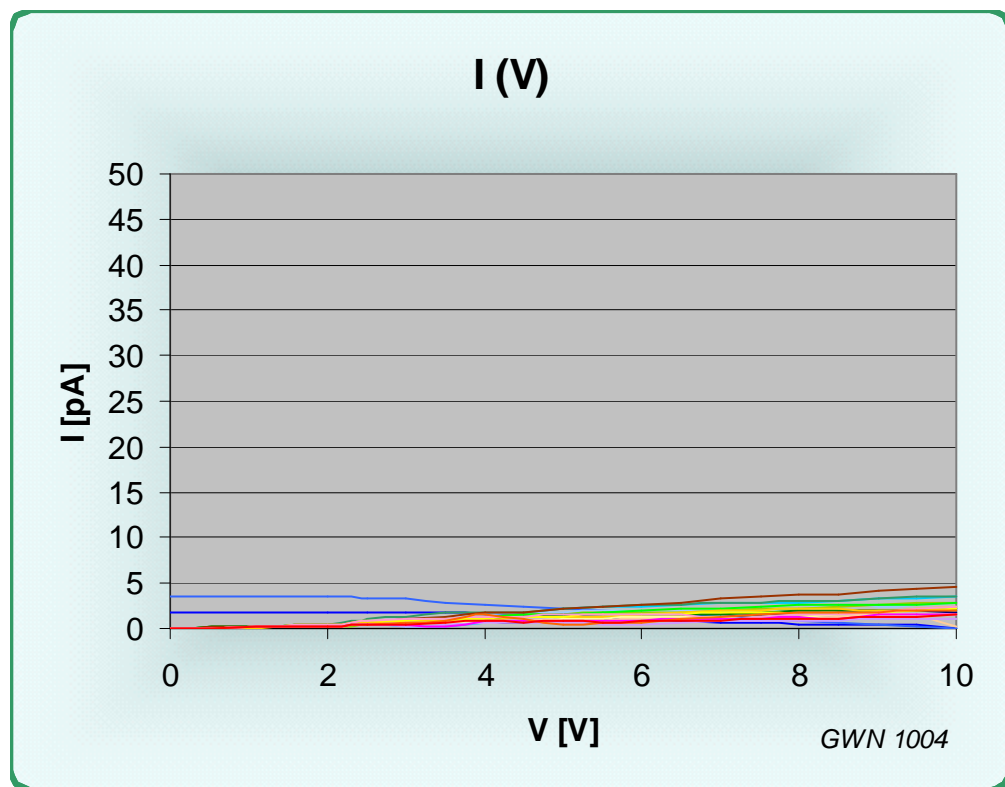
Figure 16 Leakage current as a function of drive voltage

To find any changes in the insulating performance socket materials and to identify any adverse contributions from debris accumulation, the leakage current was measured as a function of excitation voltage between the probe and all other test pins (ground):

Leakage is very low and is near the system limits of a few pA.

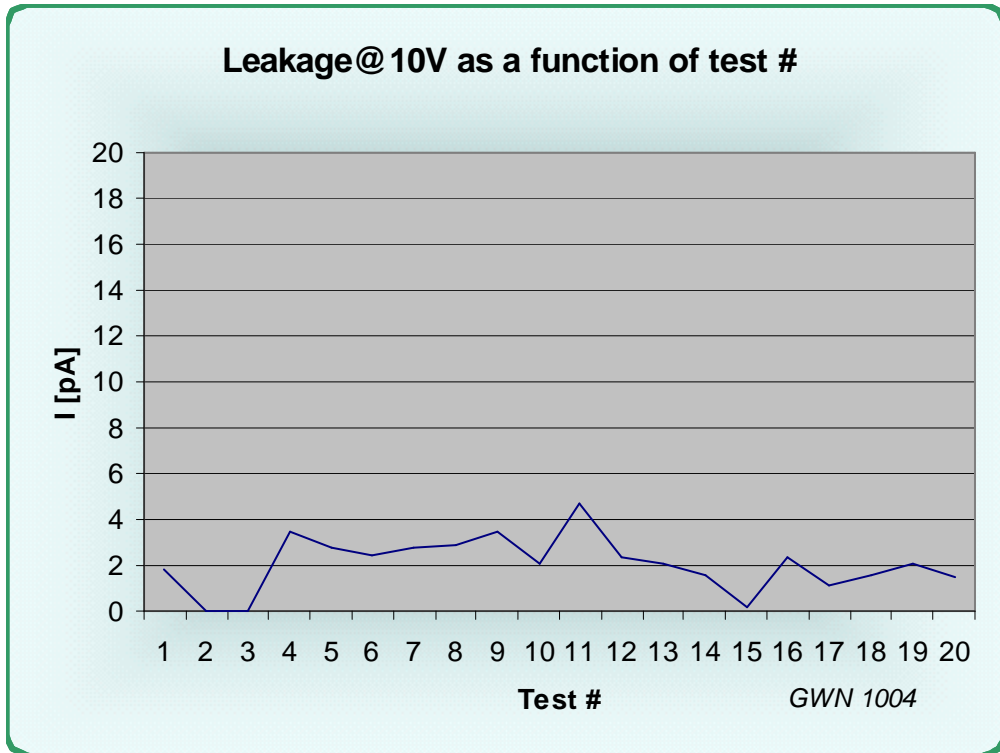
Figure 17 Leakage current @10V as a function of cycle #

Also of interest is the evolution of leakage with the number of test cycles. As such, the current observed at the 10 V excitation level is shown as a function of the test cycle number:

All values are within the system uncertainty. After the first four cycles an enhanced measurement technique was used. Values in the first four cycles are saddled with a greater system uncertainty, and hence may show larger leakage than actually present.

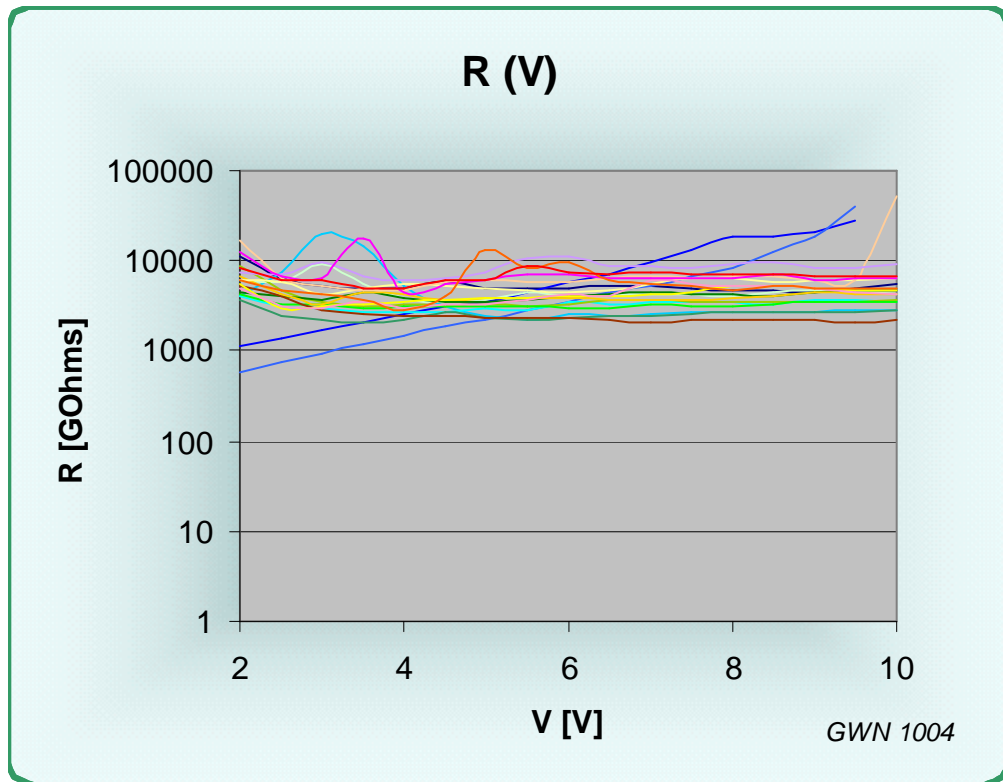
Figure 18 Leakage resistance as a function of drive voltage

Total resistance values are very high and do not give any cause for concern.

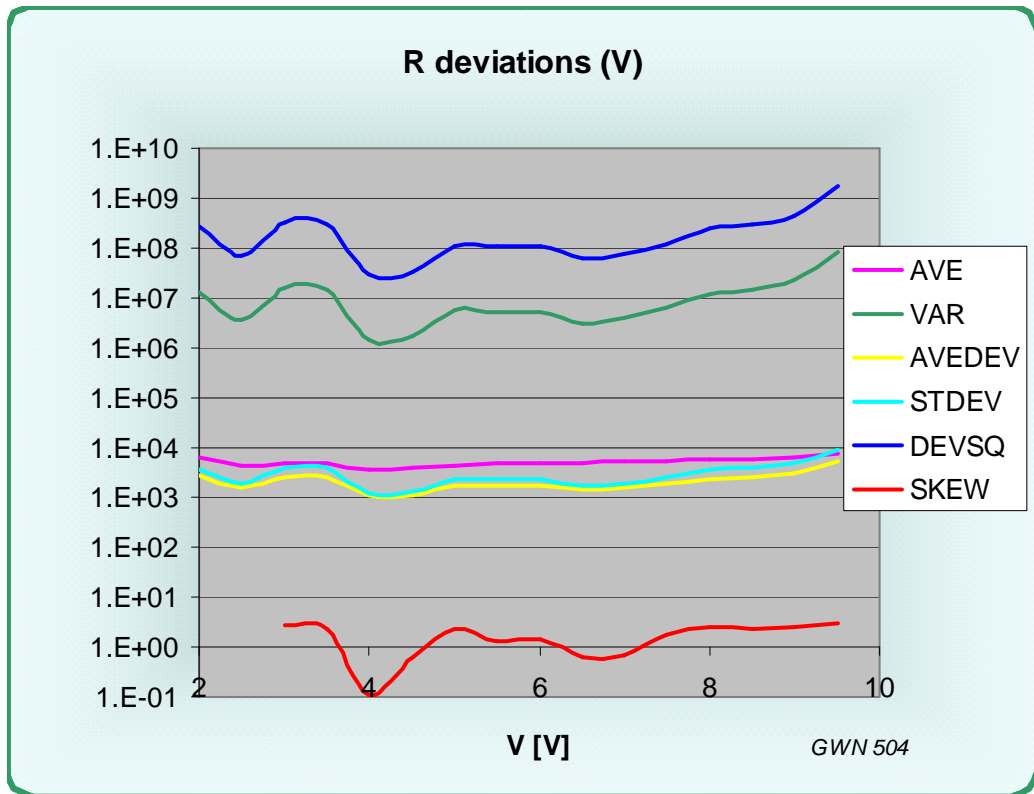
Figure 19 Leakage resistance variations as a function of voltage

Values vary greatly, but of course all of them are at the very limit of the system capabilities.

Thus, it is somewhat difficult to consider deviations in an appropriate manner:

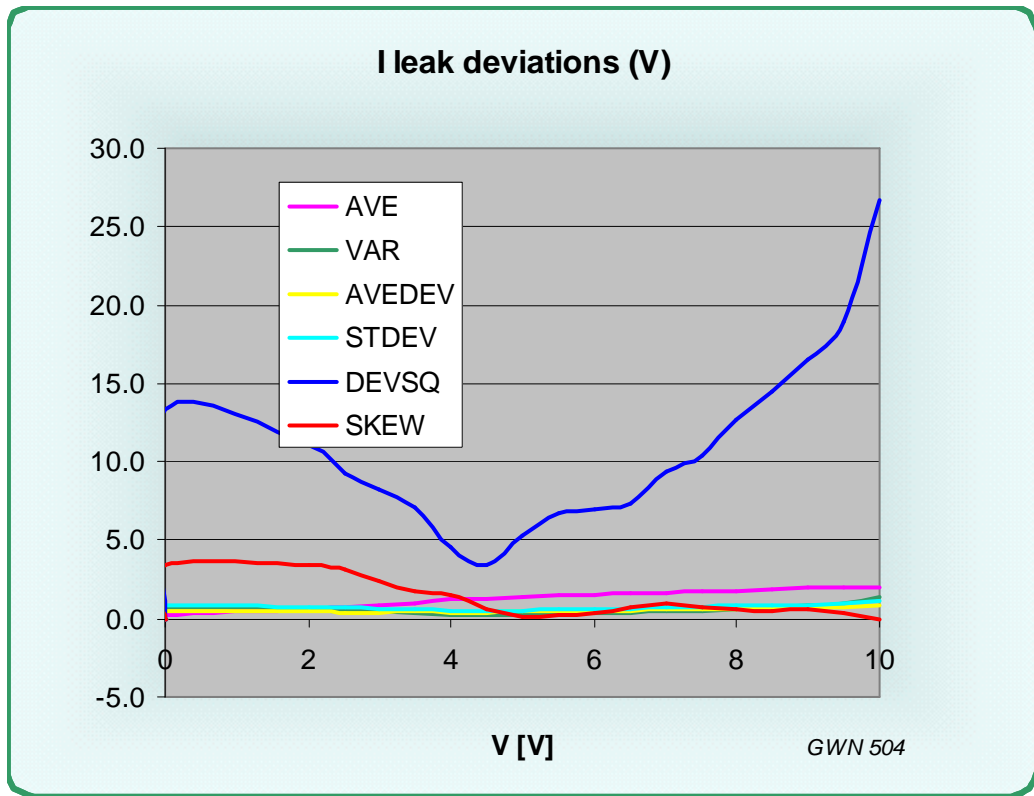
Figure 20 Leakage current variations as a function of voltage

Resistance variations will, of course be very large and it is thus perhaps better to consider leakage current statistics as shown below:

There are no anomalies in this response and no excess current is evident.

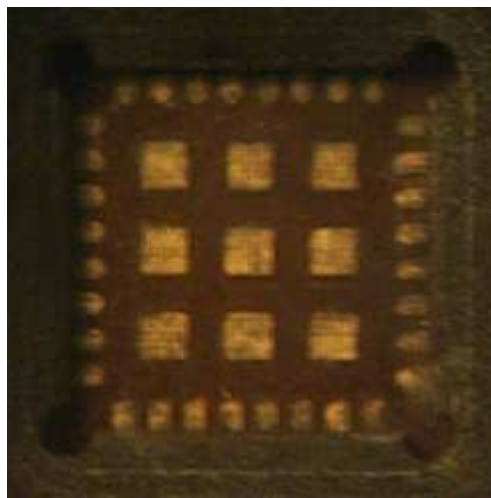
Figure 21 Socket appearance after the last stage of cycling (before cleaning)

During the cycling, small amounts of metal from the surrogate devices collected in the socket. Hence, sockets were periodically cleaned with a light brush to remove the larger loose particles. The picture below shows a view of the socket after the last stage (1M cycles total) and before cleaning:

The contacts showed little wear despite the fact that the high number of cycles with the same surrogate device led to exposure of the underlying materials in the DUT.

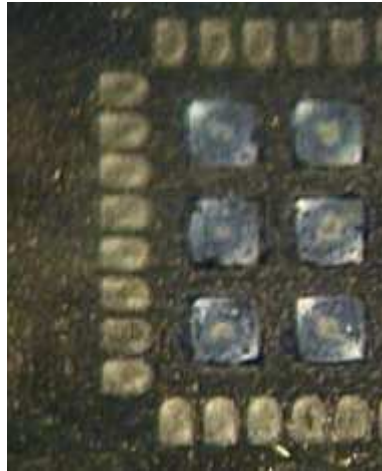
Figure 22 Base plate shows some wear due to socket

Also of interest were possible wear patterns caused by the contacts in the Au covered base plate. An image shows the area of that plate after the full complement of cycles. It should be noted that not only have the sockets been cycled to 1 million actuations, but also were mounted and demounted a large number of times on this plate.

A visible wear pattern is discernible, indicating that pulsating forces or movement is transmitted to the PCB side of the socket from the DUT side during device insertion. Wear patterns in the surrogate device, of course, are also somewhat noticeable. This is not relevant to the socket assessment, however, since here surrogate devices were subjected to very large numbers of repeat insertions, a condition which does not reflect the operating environment found in the actual application.
